Ground deformation caused by fault reactivation: some examples

LAURANCE J DONNELLY¹ MARTIN G CULSHAW G², FRED G BELL² AND DOUG TRAGHEIM²

Abstract: Faults, when located within an area undergoing mining subsidence, are susceptible to reactivation. Residual movements along faults may also occur long after mining has ceased, although this can be difficult to prove. Fault reactivation can result in the disruption of the ground surface due to the formation of fault scarps. These features are often referred to by subsidence engineers as 'steps' in the subsidence profile or 'break-lines' along the ground surface. Reactivated faults vary from subtle disturbances along the ground surface to major topographic scarps up to 4 m high and 4 km long. These may, or may not, be accompanied by fissuring, compression, lateral spreading, graben formation, groundwater discharge, mine gas emissions, acid mine drainage and shear displacements. In spite of reactivated faults being widespread throughout Great Britain, in existing and former mining regions, these types of ground movements are not always widely appreciated by engineering geologists, geotechnical engineers, civil engineers and planners. The

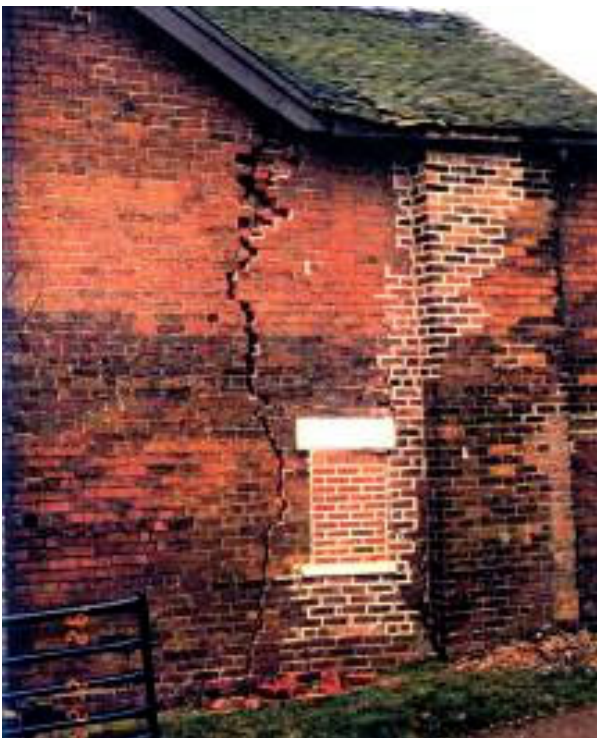
Damage to detached houses by fault reactivation may vary from the subtle (cracking of plaster and bricks) to the severe (evacuation of occupants and subsequently demolition). Examples occur throughout Britain. For instance, a large detached house was situated on the outcrop of the Hopton Fault, Oulton, Staffordshire (Figure 1). This suffered repeated damage each time the fault was undermined by longwall workings. By January 1993, the scarp was distinct, high-angled, 1.0 to 1.5 m high and could be traced for 2 km. The house was eventually demolished due to severe structural damage. The scarps were subsequently ploughed flat on adjacent land, road 'steps' were eventually repaired and a new house built on the same sites, a few metres from the original fault scarp and house position.

Figure 1. Damage to houses caused by the mining-induced reactivation of the Hopton Fault, Oulton, Staffordshire, UK.

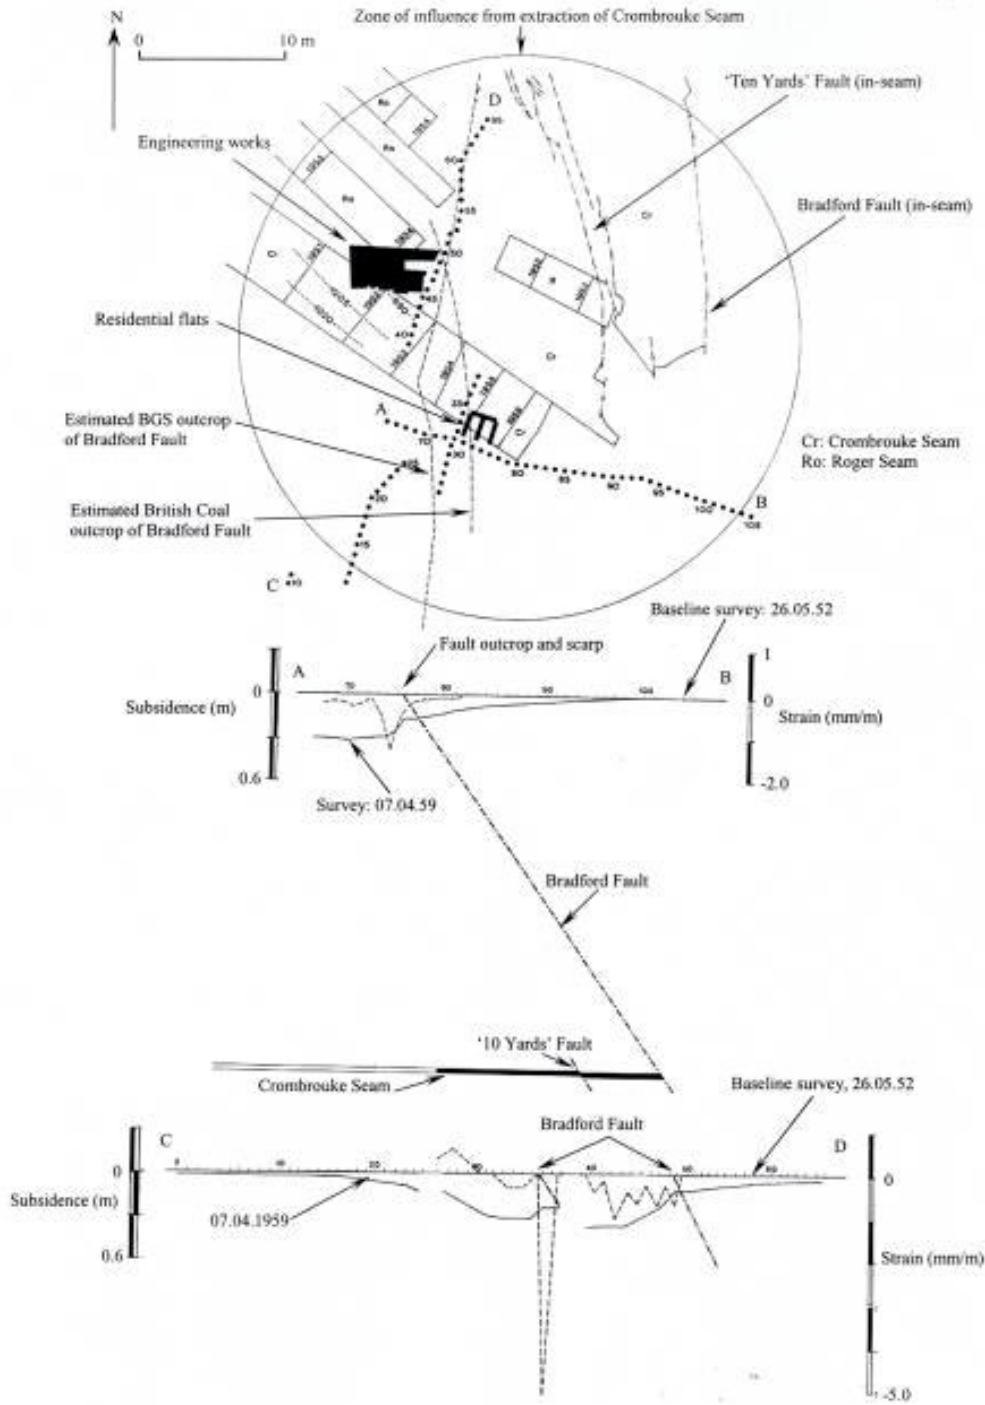
Crompton Hall residential apartments building, built in the early part of the 1900s, was located in the densely populated, industrialised part of the East Lancashire Coalfield (known as the Bradford Coalfield) to the east of Manchester. The Bradford Fault, one of the principal faults that cross the coalfield, outcrops approximately 5 km to the east of Manchester city centre. The Bradford Fault was observed in underground workings at the former Bradford Colliery, not as a single dislocation, but as a shatter zone up to 90 m wide, consisting of numerous broken and interlocking discontinuities. At least six seams had been extracted from the beneath the fault. The reactivation of this fault was detected on two survey lines, one at an acute angle to the fault, the other perpendicular. Reactivation resulted in the generation of a scarp along the ground surface with compressive strains of 4.91 mm/m (Figure 2). The flats suffered moderate to severe damage, and they were subsequently demolished (Marr 1961, Lee 1965, Donnelly 1994).

Figure 2. Schematic illustration documenting the reactivation of the Bradford Fault, Lancashire, UK, showing the suspected outcrop and in-crop positions of faults and survey lines (upper), subsidence data recording the development of the subsidence trough and fault reactivation along the cross sectional (middle) and transverse (lower) subsidence monitoring lines.

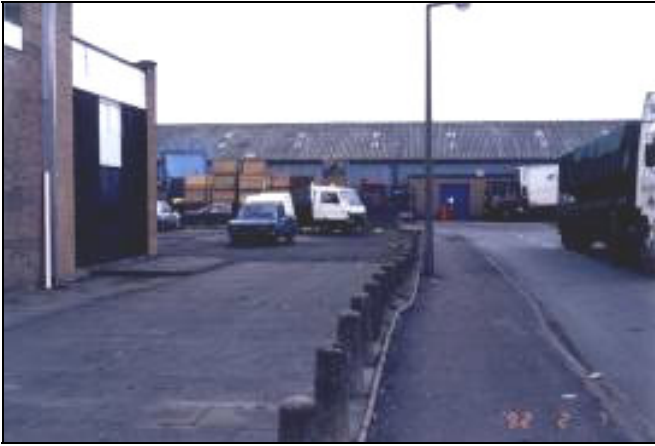
Moderate damage was caused to an industrial estate and sewerage treatment works at Newstead, Stoke-on-Trent, during the reactivation of the Hollybush Fault in the early 1990s. Damage was consistent with the mining of the Yard and Great Row seams from the former Trentham Colliery. Dextral shear displacements of up to 0.2 m occurred along the fault, which outcropped through the industrial estate and a conspicuous scarp, with vertical displacements of up to 1.0 m, were observed (Figure 3).

Figure 3. Lateral shear along the outcrop position of the Hollybush Fault, Staffordshire, UK. Note the 0.1 to 0.3 m of shear displacements to the kerbstones, paving slabs and the building's wall.

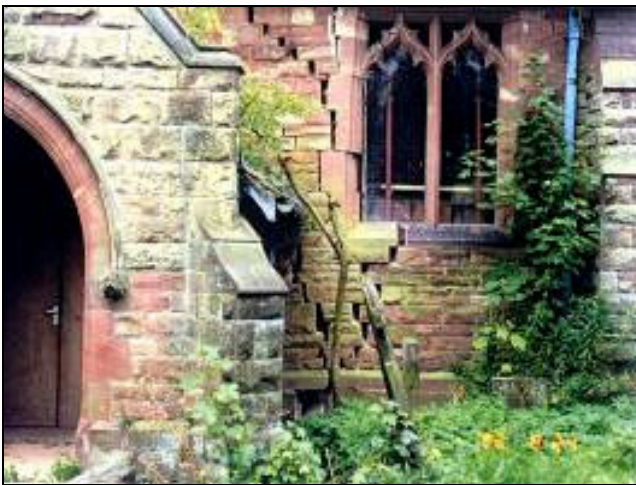
Barlaston Church is situated adjacent to Wedgwood Hall, in Staffordshire south of Stoke-on-Trent. Both are heritage sites of historical value. Wedgwood Hall was built between 1756 and 1758, and the church was rebuilt in 1760. As a consequence of extensive coal mining, subsidence and reactivation of the Hollybush Fault, in the late 1980s and early 1990s, both of these buildings were severely damaged (Figure 4). The two buildings became unsafe, but could not be demolished since they are listed as sites of national heritage. They have had to undergo extensive stabilisation works. The church has been partially rebuilt, with its tilted and detached tower being straightened, and the hall was underpinned. Bedding plane translational shear at a faulted contact was the likely mechanism responsible for the generation of the distinct fault scarp. This occurred at the contact of a sandstone and mudstone in the Carboniferous Halesowen Formation.

Figure 4. Barlaston church, Staffordshire, UK, was severely damaged by mining induced fault reactivation. The church was partially rebuilt, the tilted and damaged tower and the historical Wedgwood family graves stones repaired.

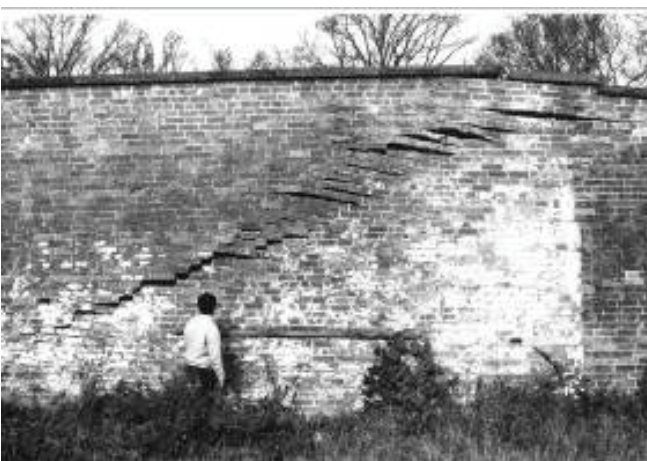
Walls are particularly vulnerable to damage by mining subsidence fault reactivation. They may become tilted, distorted, skewed or fractured. Frequently, it is the damage to perimeter walls and retaining wall, which provides the first evidence that fault reactivation may have occurred. A typical example was the reactivation of a fault at Eastwood Hall, Nottinghamshire, in the 1980s. This caused a high degree of localised buckling to a 5.0 m high brick wall accompanied by the appearance of fault scarp 0.3 m high (Figure 5). Surface buildings were also severely damaged and required rebuilding (Donnelly 2000b, Whittaker & Reddish 1989).

Figure 5. Compression to a 5.0 m high retaining wall, caused by fault reactivation and subsidence, Eastwood Hall, Nottinghamshire, UK.

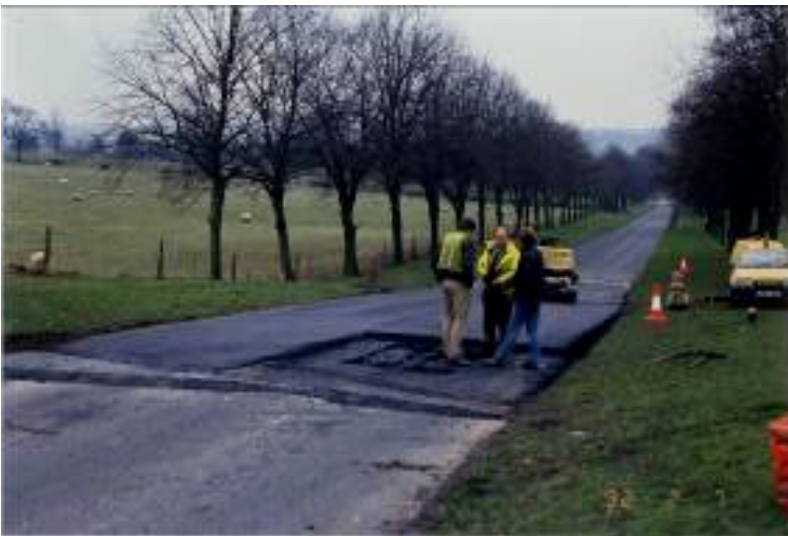
Fault reactivation and road damage was caused by workings at Hem Heath (previously Trentham) and Florence collieries (Donnelly & Rees 2001). These scarps across roads may reach 2.0 m in height and may be traced across the ground surface for distances of several hundreds of metres. The Crowcrofts Fault outcrops on Wedgwood Drive, near Barlaston, south of Stoke-on-Trent in Staffordshire and from the 1960s to the 1990s underwent several phases of reactivation separated by periods of relatively stability. This was caused by the longwall working of multiple coal seams. A fault step, varying from a subtle flexure to a distinct steep-sided fault scarp over 1 m high, could be traced for a distance of over 3.5 km. Road repairs were necessary on a regular basis causing local traffic delays (Figure 6). The road was repeatedly surveyed over a period of several years and, more recently; these results have been compared with those obtained from satellite radar interferometry (Culshaw *et al.* 2006).

Figure 6. Repairs to Wedgwood Drive, Barlaston, Staffordshire, UK, caused by the reactivation of the Crowcrofts Fault. This generated a scarp at least 1.0 m high and 1.5 km long, during multiple phases of reactivation from the 1960s to 1990s.

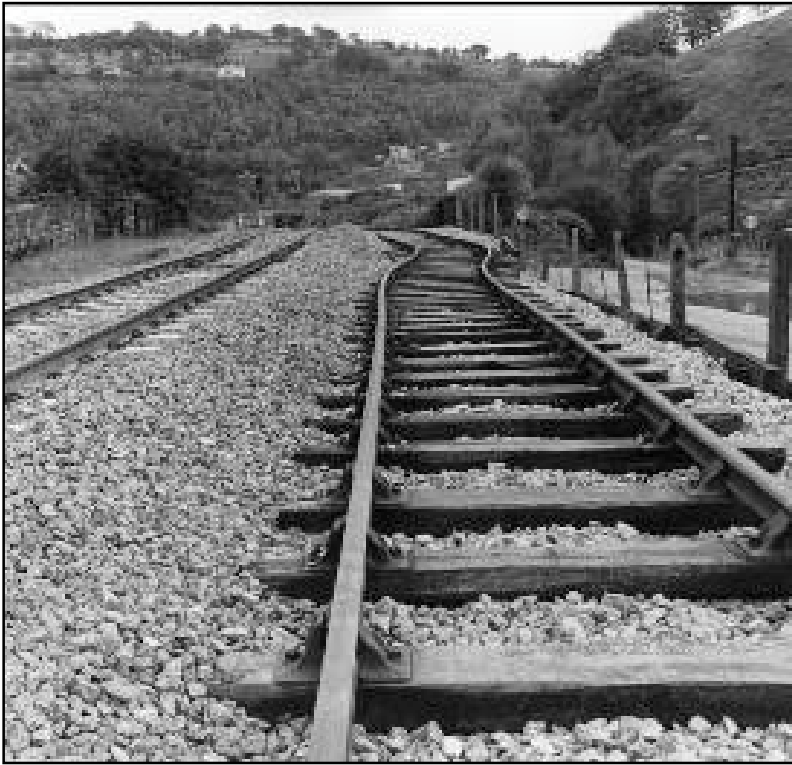
There are few examples of mining-induced fault reactivation damage to railways lines. In South Wales, the reactivation of the Kilkenny Fault in the 1990s and 1990s generated a fault scarp 1.5 m high, which caused severe buckling of the Cardiff to Merthyr Railway, nearby roads, a railway bridge and associated infrastructure (Figure 7). The longwall working of the Seven Feet Seam caused the most widespread and extensive damage to the railway line at Quakers Yard. The fault trends northwest-southeast, consistent with the main regional trend for major faults across the coalfield.

Figure 7. Reactivation of the Kilkenny Fault, South Wales, UK causing severe damage (compression) and buckling to the Cardiff to Taff Merthyr railway tracks.

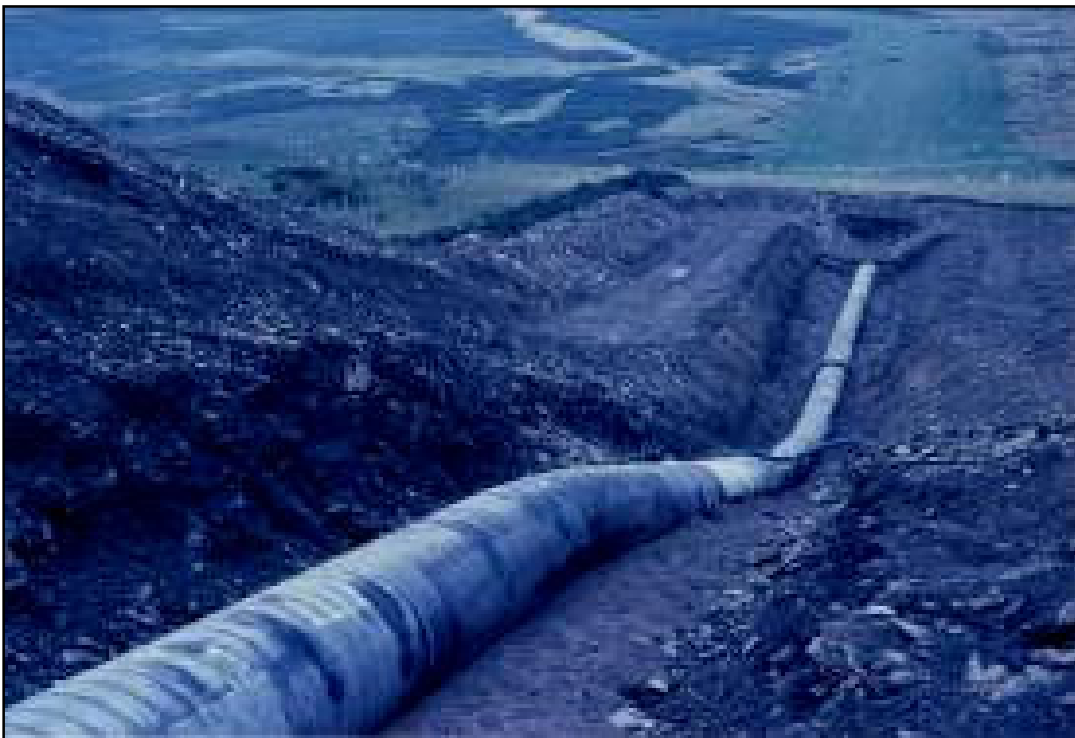
In South Wales, the northwest-southeast trending Rhos Fault forms the south-western edge of the Dowlais Trough and has a throw of 119 m in the Brithdir Seam and 91 m in the Seven Feet Seam. The fault was observed in underground workings from the Taff Merthyr Colliery and consisted of highly slickensided rock with prominent ductile drag folding of the strata adjacent to the fault. The Rhos Fault crossed the 1.2 m diameter, very high pressure (VHP) Dowlais to Nelson Gas Main, on Gelligaer Common. This is an elevated area of ground in an urban part of the coalfield. The fault was scheduled to be undermined by an advancing longwall panel in the Brithdir Seam, which occurs at a depth of approximately 660 m. A ground monitoring programme was implemented to ensure that the gas main did not buckle and rupture during the anticipated reactivation of the Rhos Fault, accompanying the subsidence. The survey consisted of precise levelling observations, total station and electronic distance measurements. The gas main was exhumed and exposed in a deep observation trench to monitor strain accumulations (Figure 8). Approximately 0.6 m of vertical displacement was measured along the fault, accompanied by fissuring on the moorland and road. As a result, the extraction of the seam was terminated to prevent further damage to the gas main (Donnelly 1994, 2000a).

Figure 8. Influence of fault reactivation on gas mains. The Nelson to Dowlais gas main, exposed for strain accumulations and subsidence monitoring where it crossed the Rhos Fault, South Wales, UK.

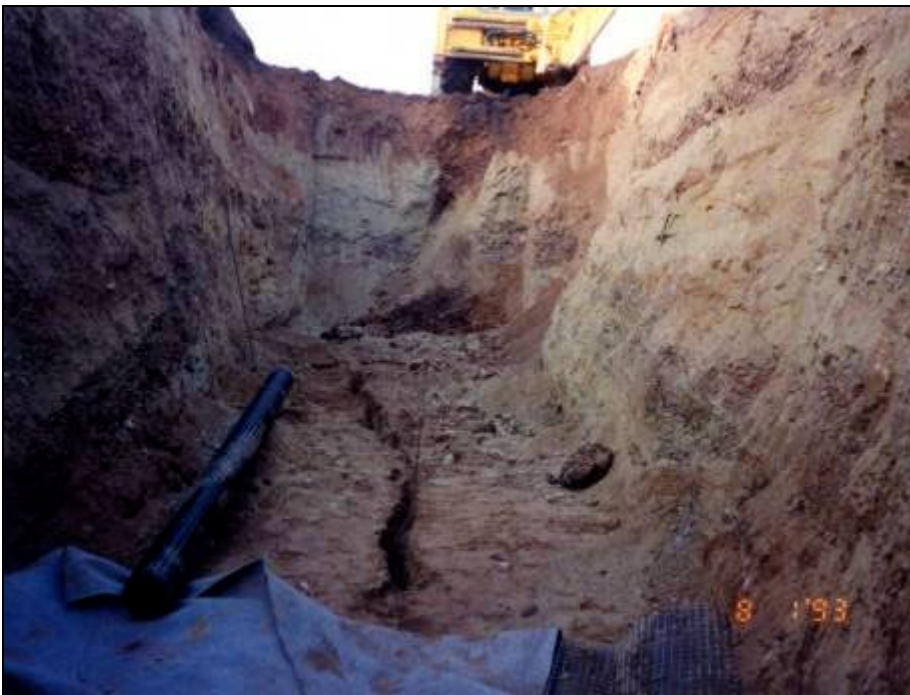
Buried communication cables, located about 0.5 m below ground level, were damaged by the generation of ground fissures in the Triassic rocks of Downes Bank, Staffordshire. The area rises to almost 50 m in height above the Carboniferous Coal Measures rocks of the area and is generally free of Quaternary cover, but is covered by a thin sandy soil. Several faults were subjected to subsidence in the 1990s. This caused the dilation of the fault plane with, or without, a component of vertical slip and resulted in the generation of the ground fissures. Some fault-fissures strike for a distance of over 1 km; their depths are unknown but have been estimated to be at least several metres. These represent the dilation of faults and joint sets during mining subsidence. Where observed in cross-section, in 10 m deep trenches, the faults consist of distinct, parallel and sub-parallel dislocations with a loose sandy gouge. Fissures in the ground surface caused by fault reactivation have been observed in other parts of Britain where the Productive Coal Measures underlie strong, brittle and well-jointed rock. These include the Triassic Sherwood Sandstone Group in the English Midlands, the Permian Magnesian Limestone in the Eastern Pennine Coalfield and Carboniferous Coal Measures sandstone, such as the Pennant Sandstone, in South Wales and the Wickersley Sandstone in the East Midlands (Figure 9).

Figure 9. Fissuring associated with the reactivation of a fault, Downes Bank, Staffordshire. This caused disruption to underground communications cables. The fault is exposed in a trench and the ground stabilised using a geotextile mesh and granular fill.

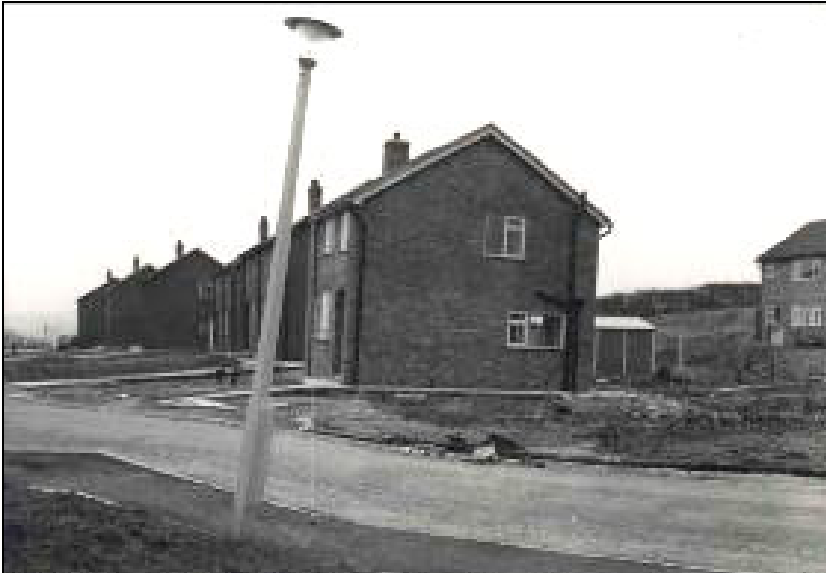
Lamp posts and telegraph poles located in areas prone to subsidence and fault reactivation may undergo an appreciable amount of tilt. A notable example occurred in Knutton, Staffordshire, during the reactivation of the Apedale Fault in 1963 (Figure 10).

Figure 10. Reactivation of the Apedale Fault, in 1963, causing tilt to a lamp post, (note the vertical string hanging from the lamp post), Knutton, Staffordshire, UK

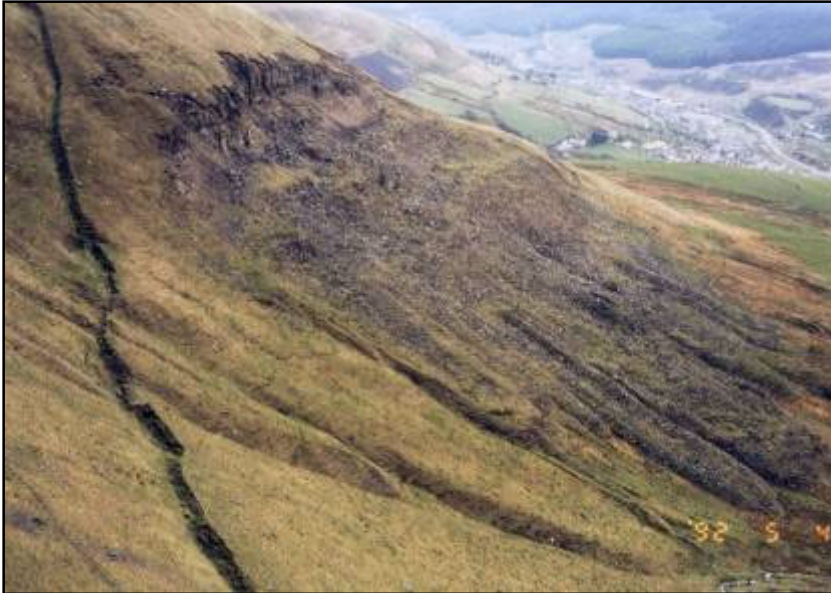
Fault reactivation can influence the stability of natural and engineered slopes. This can result in slope failure and the generation of landslides, which, in turn, may potentially damage land and infrastructure. Fault reactivation has contributed to deep-seated rotational landslides in South Wales as well as causing first time failures of slopes, long after normal ground movement caused by mining had ceased (Donnelly 2005, 2006) (Figure 11).

Figure 11. The 3-4m high and 4km long Tableland Fault scarp, which has influenced the Darren Goch landslide and displaced stream valleys, South Wales.
