Implications of urban development on escarpment instability

B I THOMAS¹, H T BROCKLEBANK² & C POWER³

Abstract: The town of Penarth, South Wales, owes its development to major industrial expansion experienced during the 19th Century. Penarth Dock was constructed at the foot of a 30m high escarpment between 1859 and 1865 primarily to assist Cardiff in receiving coal mined in South Wales via railway for transshipment abroad for export. In addition to this, quarrying of limestone from the escarpment for use in cement manufacture was also commonplace. During the late twentieth century, and after many years of neglect, redevelopment work commenced at Penarth Dock. The docks area was partially infilled and the rail tracks and sidings removed. A marina with high quality residential and commercial buildings was constructed in its place. This redevelopment has brought about the need for car parking and a boatyard in close proximity to cliffs of marginal stability in areas of enhanced public access. The escarpment, which comprises sediments of the Mercia Mudstone Group overlain by deposits of the Penarth Group, has suffered a number of slope failures and rockfalls over recent years; the mos

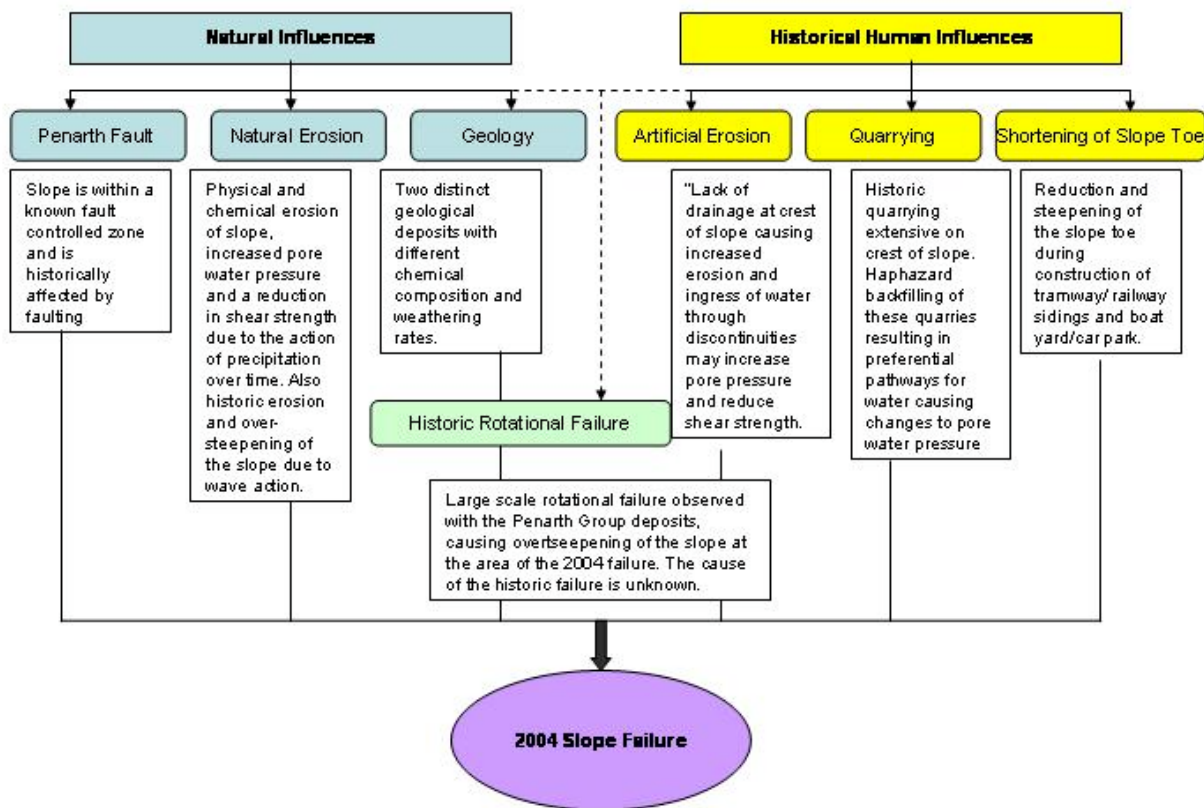
A combination of natural and historical human influences affecting Penarth Escarpment has contributed to the 2004 slope failure. However, the historical rotational failure, the back scarp of which was noted immediately upslope of the 2004 failure, has undoubtedly influenced the stability of the escarpment in this area, and is very likely to have had a significant influence on the 2004 slope failure. The position of this older failure may be related to geological faulting (the Penarth Fault) and its occurrence may also have been affected by human activities such as changes in slope geometry from steepening of the slope during the construction of the rail sidings at the toe of the slope. Rotated blocks and beds of the subordinate competent mudstone observed within the 2004 failure scar during the roped access surveys, confirm that the recent failure is simply a small section of a much larger historic failure. Figure 2 summarises the main factors influencing the failure.

Figure 2. Factors Influencing the 2004 Slope Failure on Penarth Escarpment

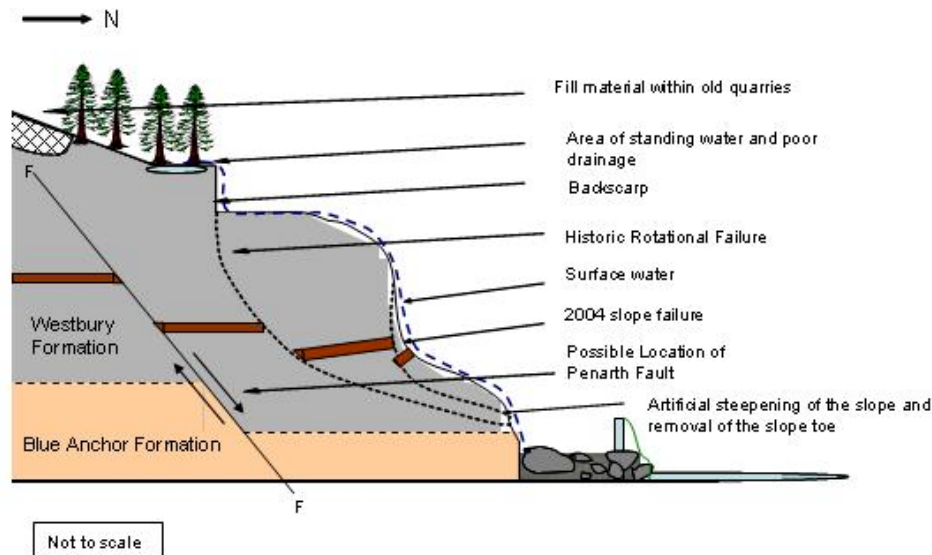
A simplified sketch explanation of the slope failure is given in Figure 3 and clearly shows that the 2004 slope failure at Penarth Escarpment resulted from a combination of natural influence and human influence, as well as the position of an older, pre-existing slope failure.

Figure 3. Simplified Explanation of the 2004 Slope Failure
