Stability analysis and safety assessment of high cut slopes in new towns for the Three Gorges Project population migration, China

R. Q. HUANG, X. J. PEI

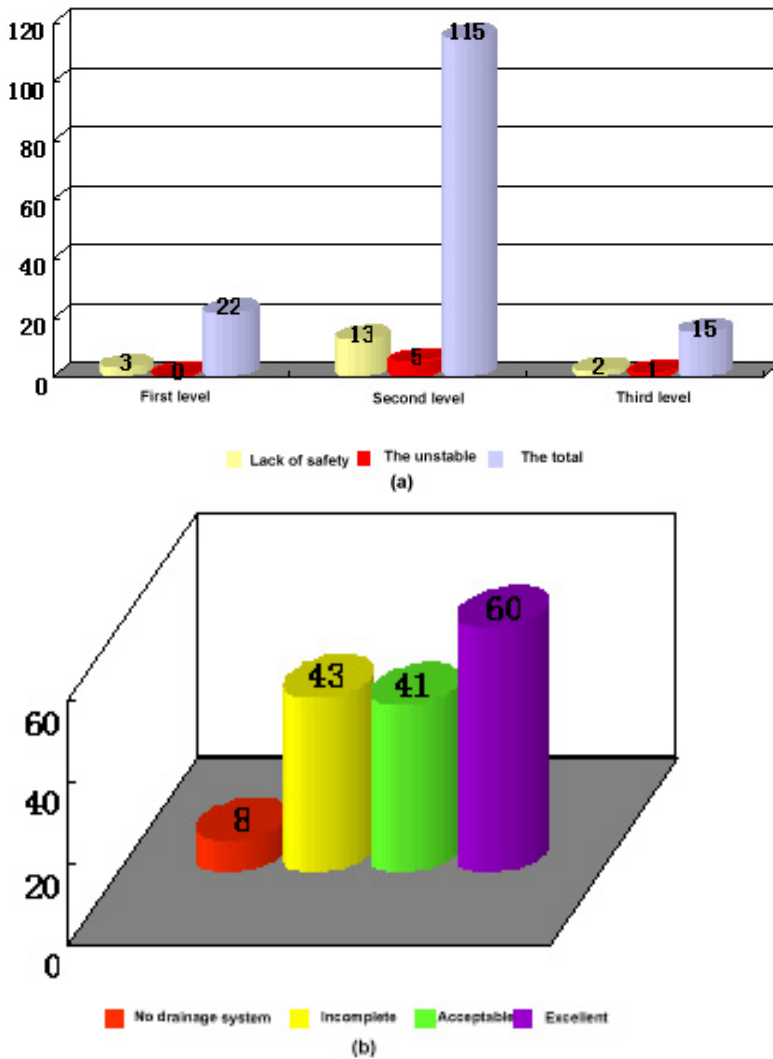
The Evaluation Team undertook in situ investigation and data collection for 152 high cut slopes for 40 days and analysis and collation of the data for a further 30 days. There were 10 rock slopes, 19 rock and soil slopes and 123 earth slopes investigated. 148 of all the high cut slopes had been treated, and included 95 gravity retaining walls, 3 anti-slide piles, 3 pile sheet retaining walls, 33 ribbed plates, lattices and anchors, and 14 multiple retaining walls. In the appraisal report there were 16 slopes that were considered unsafe and 6 slopes that were at the point of failure. Different grade distributions can be seen in Figure 5.

- 1) An evaluation of the stability of 152 high cut slopes related to immigration in Fengjie County led to three categories of slopes according to slope type, height and failure mechanisms. 130 (85%) slopes were found to be safe, 16 (11%) slopes were found to be just safe and 6 (4%) slopes to be unsafe. Most slope treatment measures for high cut slopes were found to be reliable. Stabilisation of the high cut slope contributed to the fact that the new towns could be built and the reservoir filled on time.
- 2) Main geological issues induced by engineering construction or failure included inadequate drainage systems for the slopes or the retaining walls, incomplete rain and flood hazard prevention and mitigation systems, and not assessing the affect of building on retaining walls and cut slopes. Engineering construction and monitoring needs to be coordinated.

Figure 5. Safety appraisal results of high cut slopes in Fengjie New Towns: (a) appraisal results of different safety grades for high cut slopes; (b) investigation results of drainage systems of slope engineering

Following this appraisal the following recommendations for preventing failure of high cut slopes are as follows:-

- 1) Perfection and maintenance of drainage systems including the surface water drainage systems, the sub surface drainage systems and the city sewage systems.
- 2) Complete slope monitoring system should exert an influence on treatment of the slopes.
- 3) Further checking of the stability of the slope with different scenarios to take into account changes in plans should result in guidelines for additional stability mitigation measures.
- 4) Rock retaining walls, rockfall trenches and protection nets used where necessary.
- 5) Vegetation protection measures reinforcing the slopes should be taken.
