# Research into the characteristics of the Jin Jiguan Tunnel's geohazards and their control

**Abstract:** The Jin Jiguan Tunnels on the Chuan-Zang Highway at Ya-an town were opened to traffic in January 1995. However, in 2001 the twin tunnels were found to be suffering from water penetration and deformation phenomena to varying degrees with heave and rock fracturing evident at several places within the tunnels. This had some detrimental effects on the normal use of the tunnels. Based on field investigation and other studies by the authors, it was concluded that three main factors contributed to the geohazards appearing in the tunnels. The first involved expansive soils present in the Guan-kou lithostratigraphical unit that expanded when they came into contact with water and caused arching and deformation of the road surface. The second factor stemmed from a combination of poor practice, inadequate equipment and uncontrolled working conditions during construction that caused fractures and construction crevices within the tunnel linings. Gypsum in the Guan-kou formation was dissolved by groundwater that seeped towards the tunnels and then recrystallized along the fractures and crevi

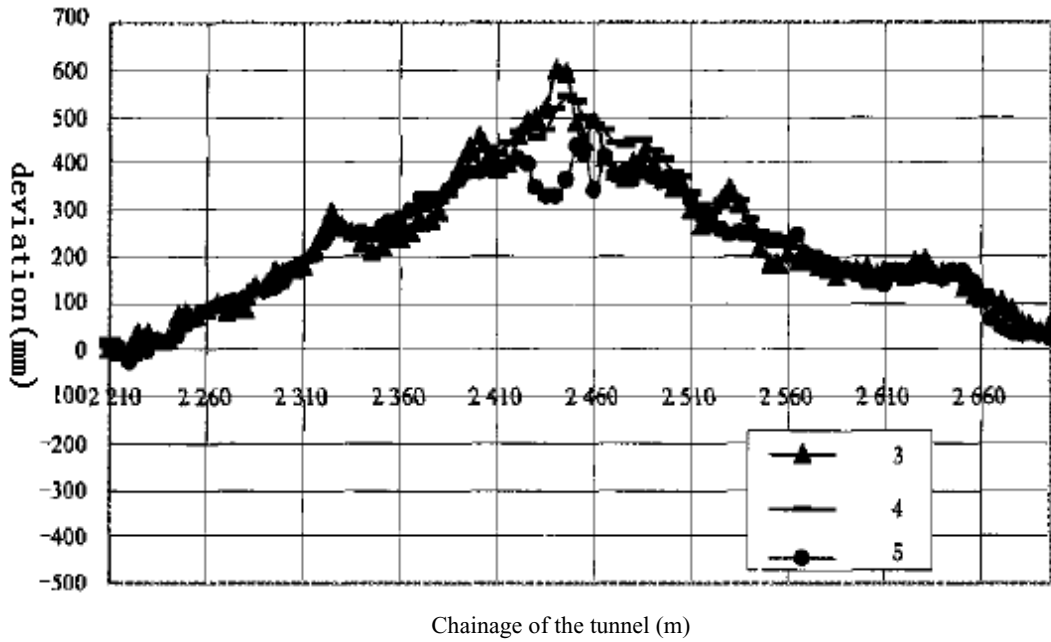
Geological surveys of the tunnels identified the principal sections where the current height of 3 ground baselines deviates from the original design height. These are from chainages 2310 m to 2650 m along No 1 Tunnel and from 2285 m to 2485 m at No 2 Tunnel (see Figures 3 (a) & 4(a)). The deviation increases from the ends towards the middle of the tunnels with the maximum deviations from 2440 m to 2450 m at No 1 Tunnel and from 2385 m to 2465 m at No 2 Tunnel.

(a) The deviation of road surface between the current height and the design height (from 2210 m to 2695 m).

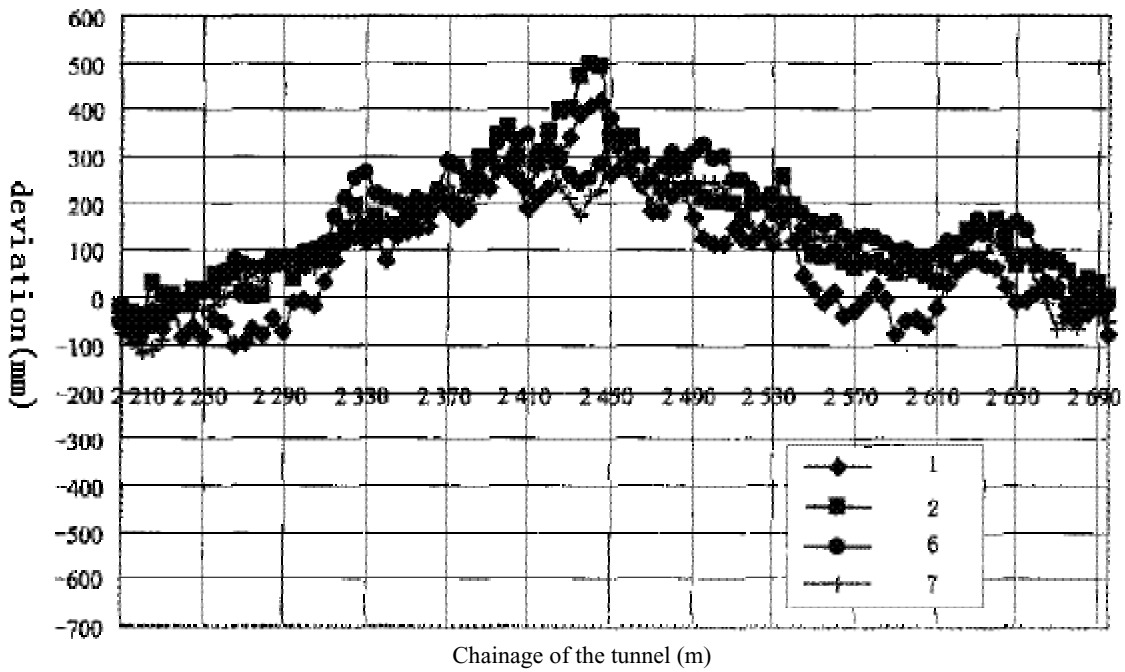
The surveys also identified the sections where the current height of 4 ground baselines on the top of ditches deviates from the design height. These are from chainages 2230 m to 2530 m along No 1 Tunnel and from 2265 m to 2465 m at No 2 Tunnel (see Figures 3(b) and 4(b)). Once again, the deviation increases from the ends towards the middle of the tunnels with the maximum deviations from 2440 m to 2450 m at No 1 Tunnel and from 2385 m to 2465 m at No 2 Tunnel.

(b) The deviation of ditch top between the current height and the design height (from 2210 m to 2695 m).

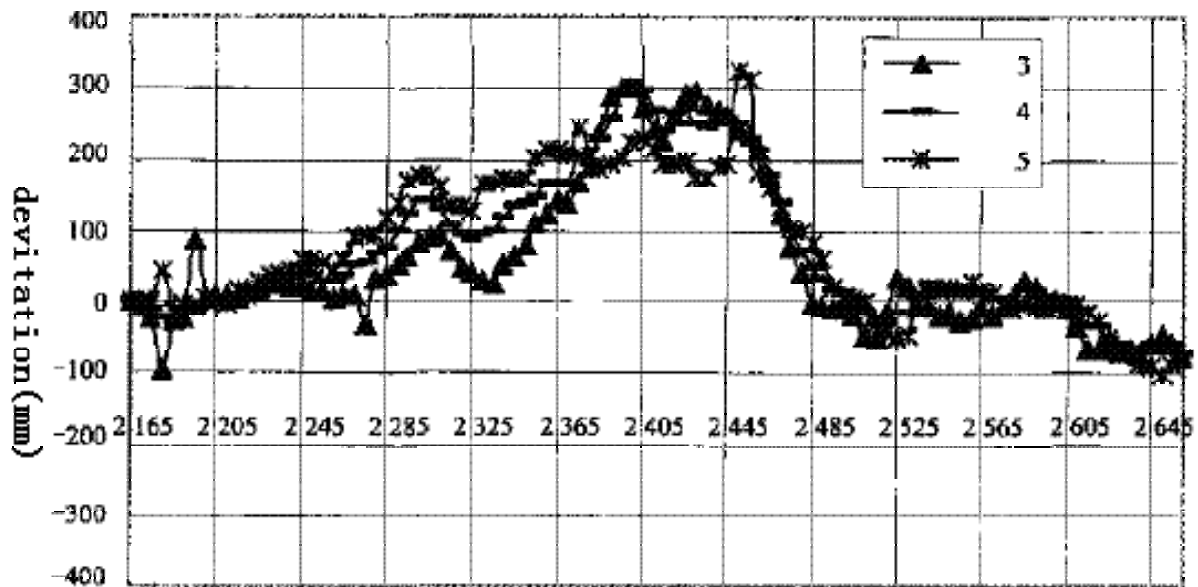
(a) The deviation of road surface between the current height and design height (from 2165 m to 2662 m).

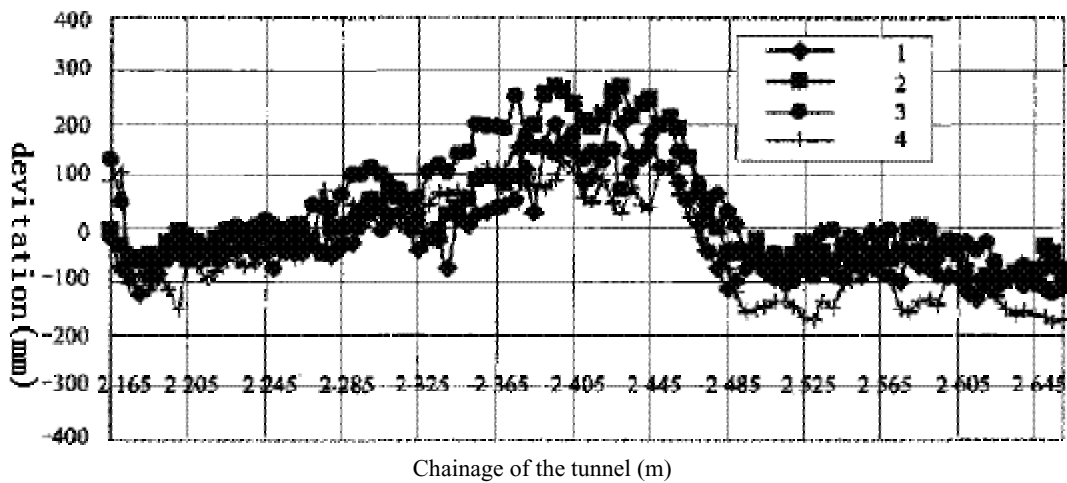
(b) The deviation of ditch top between current height and the design height (from 2165 m to 2662 m).
