Disease of bridge on the highway road 108 in the west of China (Guangyuan) and its reinforcement measures

YUN-JIE WEI¹ MO XU² & DE-MIN XU³

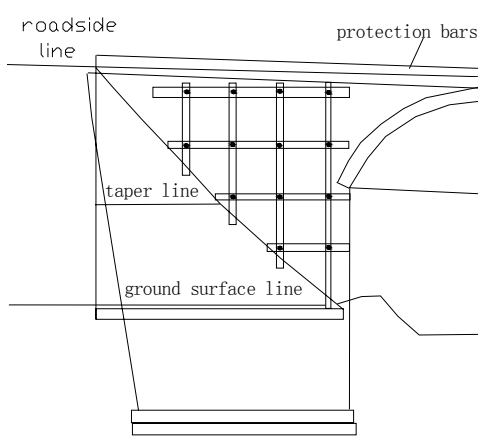
Songjiagou Bridge is located in the town of Zhongzi, it has a length of 45m, width of 13.5 m, arch height of 21m and arch span of 16m. The bridge is of masonry construction and backfilled with soil. During trial, deformation occurred in the bridge abutment and cone slope. The sidewall was found to have displaced 4 m and the cone slope cracked. Several cracks 1 to 20 mm wide were apparent in the bridge abutment protection bars (parapet) and the arch wall. The length of the slant spread is 8 to 10 m indicating a trend of gradual deterioration.

The cause to the cracking is thought to be due to the poorly compacted backfill, which has a loose structure and high void ratio. Water penetrating the structure has caused the backfill to swell reducing its strength and lowering its bearing capacity. Subsidence due to traffic load has subsequently occurred. Lateral compression of the backfill has resulted in deformation of the sidewalls and cone slope.

Grouting was performed to prevent further road subsidence. Unfortunately, sidewall displacement and cracking in the arch wall continued. The depth of grouting is limited (4 to 8 m) and it is thought that the cause of the cracking is due to backfill material below this level. Consequently, structural reinforcement using anchors/ties has been adopted to reinforce the bridge structure.

Figure 1. Layout of structural reinforcement using anchors/ties, Songjiagou Great Bridge

1. Twenty-six (26) 130 mm diameter anchor boreholes were drilled horizontally on a 3 m x 3 m grid pattern into the bridge abutment sidewalls. The holes were arranged in four horizontal rows; with four holes in the first two rows, three holes in the third row and two holes in the fourth row (Figure 1).
2. Horizontal and vertical beams are used to span the holes in each sidewall. Holes have been preformed in the centre of each beam, with sufficient space to allow for adjustment on site. The upper anchor beam is 600 mm wide and 300 mm thick and the other anchor beams 400 mm wide and 300 mm thick. The length of the beam depends on the geometry of the sidewall.

The bridge abutment has been monitored and has now been in operation for more than one year. Further distortion of the bridge abutment and cone slope has been prevented and cracking halted proving successful implementation of the method.
