Study of the formation mechanism for the Dongxi slope in the three gorges reservoir area of China

JI-LIANG ZHU¹, SHI-YUAN ZHANG², QIANG CHEN³, YUN-JIE WEI³ & XIANG-TAO XU³

Abstract: The Three Gorges Reservoir project on the Yangtze River is one of the biggest hydropower projects in the world. Chongqing province is the main reservoir area. Dongxi slope lies at Dongxi town in Chaotian County, Chongqing. The slope consists of bedded soils. It is steep sloped in the lower and upper parts and gentle in the middle. An important road and the Lanchengyu petroleum pipeline cross the slope. If the slope fails, it will do harm to the road and the pipeline and it will lead to the loss of the property, and possibly loss of life of the people who live in the town. The stability data for the slide show that it is stable under the natural conditions but it will suffer either creep deformation or mass instability under storm or storm and earthquake conditions.

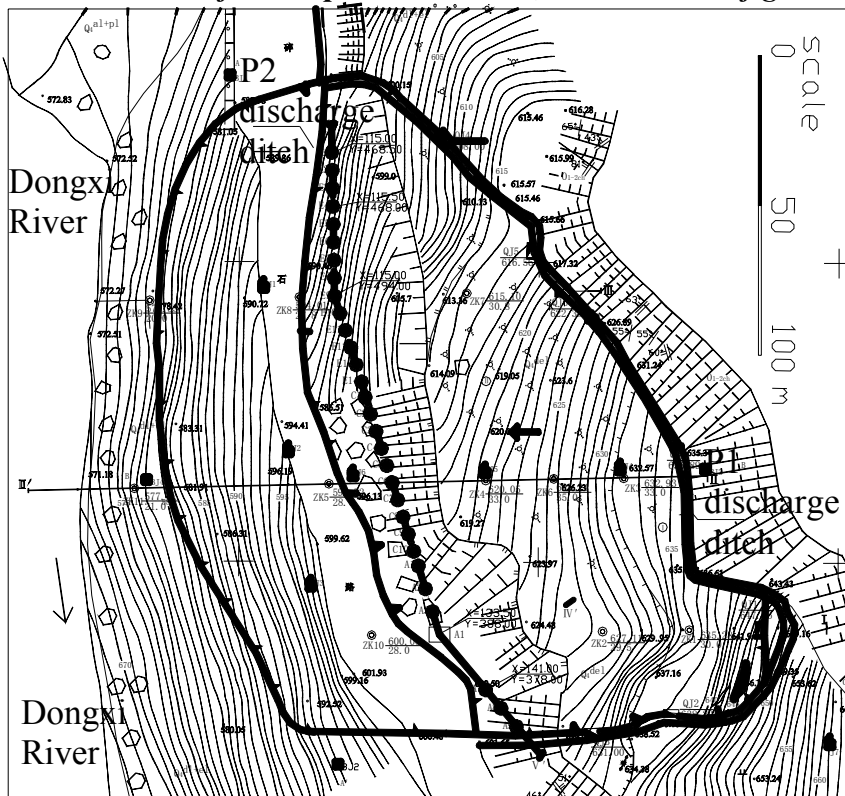
Figure 1. Map of Dongxi Slope

Dongxi slope has been reinvestigated in the recent years. It has a bowl-like shape, that is, its boundary is defined. The elevations of the upper parts is 635~650 m. Its northern upper parts are close to the ridge of the mountains and the south part has a curved tensile crack. The lower parts lie on the sloping ground between the Dongxi river and the road with elevations of 580~586 m. The difference of elevation is 44~60m between the upper parts and the lower parts.

- The macroscopic characteristics are as follows:
- The enclosed bowl shape is well developed, and there is evidence of two-stages of sliding.
- Below the northern rock cliff is evidence, and there are tilted trees which grow during the slope development, that is, the tree trunks are curved and there are slide debris on the middle-upper parts too.
- The attitudes of bed in the slope are disordered.

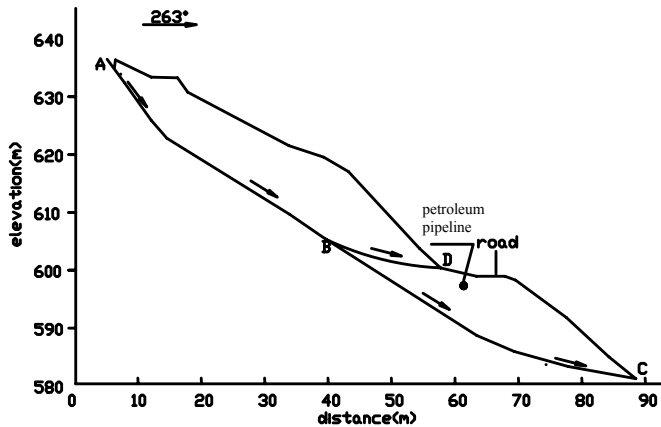
Figure 2. Cross Section of Dongxi slope

A representative section was selected (Figure 2) and stability coefficients of the ABC section and ABD section were calculated one by one under different engineering conditions. The parameters for the calculation and the stability coefficients are as follows:

The calculated factors of safety show that the ABC part and ABD parts of the slope are stable or relatively stable under natural or earthquake conditions. Its factor of safety will quickly decrease and the slope will suffer either creep deformation or mass instability under storm or storm and earthquake conditions. The calculated factor of safety of the ABD section is less than the one of ABC section, so the ABD section is more likely to fail under the same condition. The calculated result is in accordance with observations.
