Brief report of the 2016 Kumamoto Earthquake in JAPAN

IAEG Japan National Group (Japan Society of Engineering Geology)

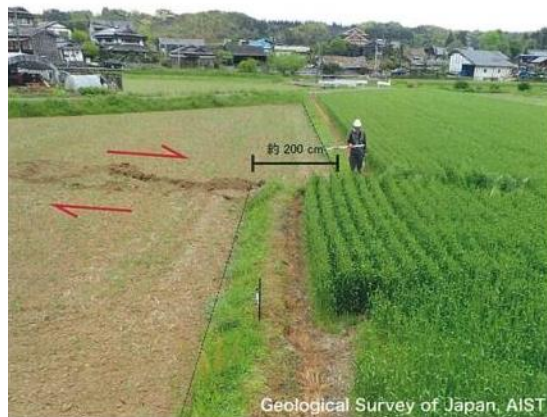
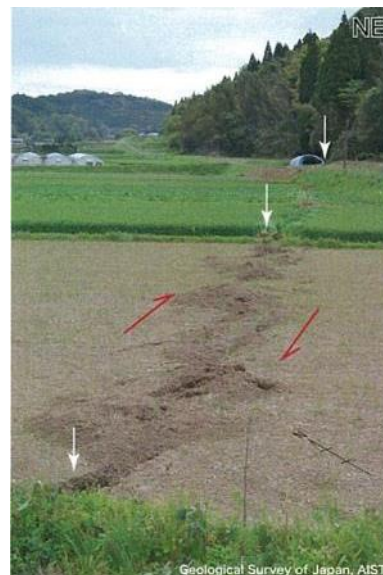
There are two right lateral active faults, Hinagu fault and Futagawa fault near Kumamoto City. According to the analysis of the surface movement by MAI (Multiple Aperture Interferometry), right slip movement along these faults are clearly shown. (Fig.5) And surface faults along Futagawa Fault with right lateral slip displacement of maximum 2 m were observed. (Fig.6)

Fig. 6 Earthquake surface fault along Futagawa Fault.
→ Right lateral slip movement was observed.

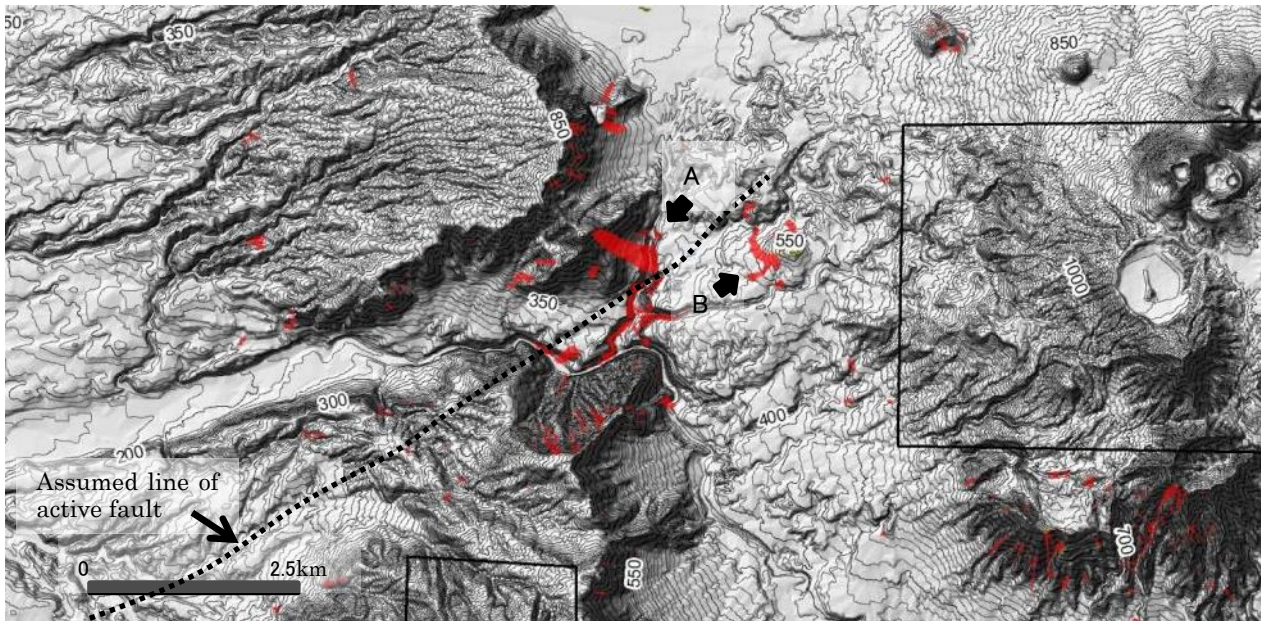
Futagawa fault continues to the northeast area of the somma and atrio of Volcano Aso. Figure 7 shows a preliminary report of the distribution of landslides and collapses in this area.

Fig.7 Preliminary analysis of landslides distribution and collapses in the west area of Volcano Aso (Assumed fault line is added.)

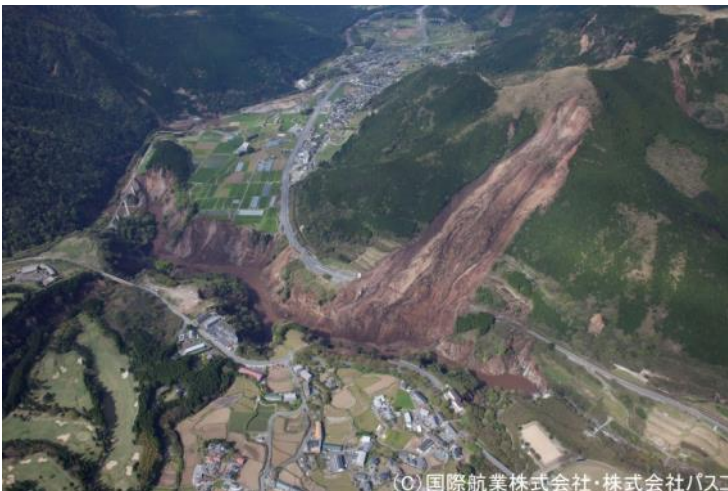
Figure 8 is the photo of steep slope collapse of near the somma just north of Futagawa Fault.

Fig. 8
Large collapse on the steep slope of near the somma of Volcano Aso (View from point A in the Fig. 7)

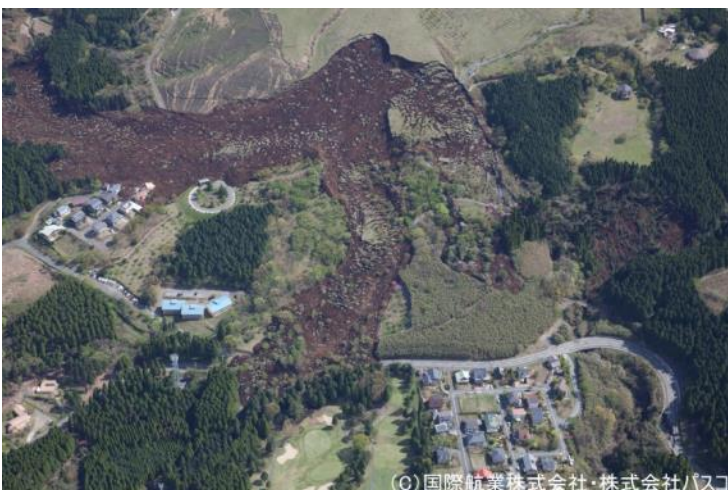
Landslide on gentle slope shown in Fig.9 would be slipped along very soft and high water content pumice layer of Quaternary tephra.

Fig. 9
Landslide flows on gentle slope of the lava dome. Landslide slip would have occurred in the tephra which covered on the lava.(View from point B in the Fig. 7)
