B. CHRISTARAS (*) - AN. DIMITRIOU (*) - E. MAZZINI (**)

ROCKMASS QUALITY AT THE FOUNDATION AREA OF THE SIMONOS PETRA MONASTERY, IN MOUNT ATHOS - GREECE.

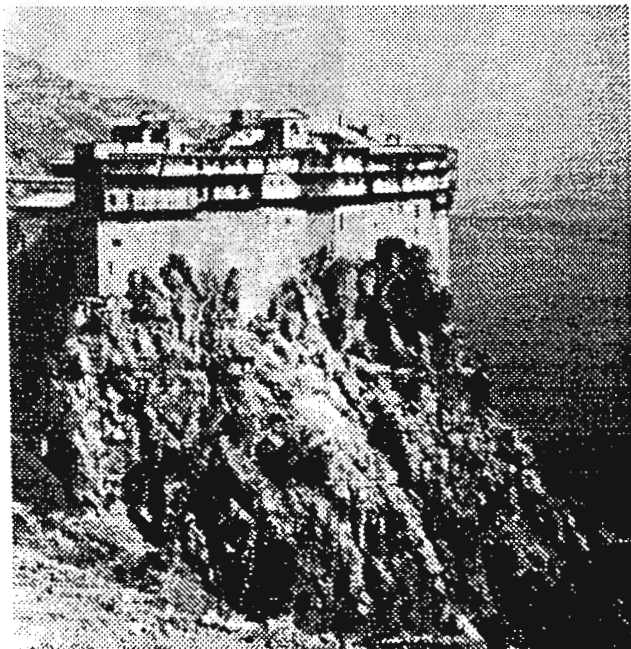
Many important faults of E-W and N-S general directions are occurred in the area. A medium to closely spaced net of joints, with rough surfaces, is related to the above tectonic directions. From a first point of view, these discontinuities could cause unstable geotechnical conditions to the rockmass, especially at the slopes of the construction area (Fig. 2).

Fig. 2 - The rockmass where the monastery is constructed.

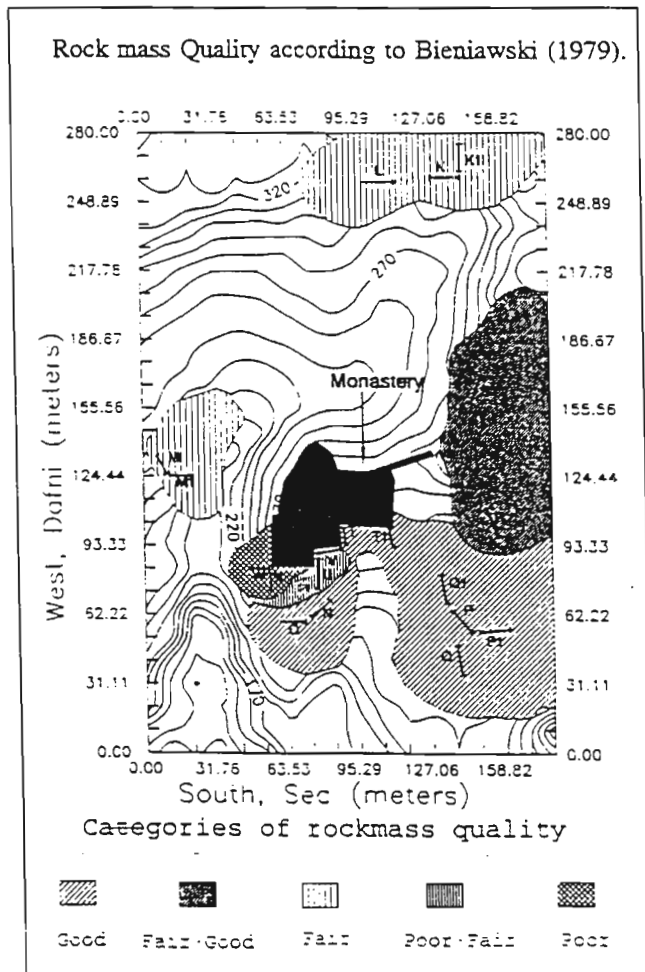
The rockmass quality was investigated at several representative sites, and a geomechanical classification was performed using the BIENIAWSKI (1974) method (Tables 1 and 2. Fig. 3).

According to the above investigation, the southern part of the foundation area presents a poor to fair rockmass quality, corresponds to the most unstable part of the monastery. Furthermore, an engineering geological sketch of the surrounding area, with faults and joints, expressed by the jointing degree, given in Figure 4, verifies the above observations.

Fig. 3 - Sketch of the monastery surrounding area with zones of similar rockmass quality (Q, P, ... sites of investigation).

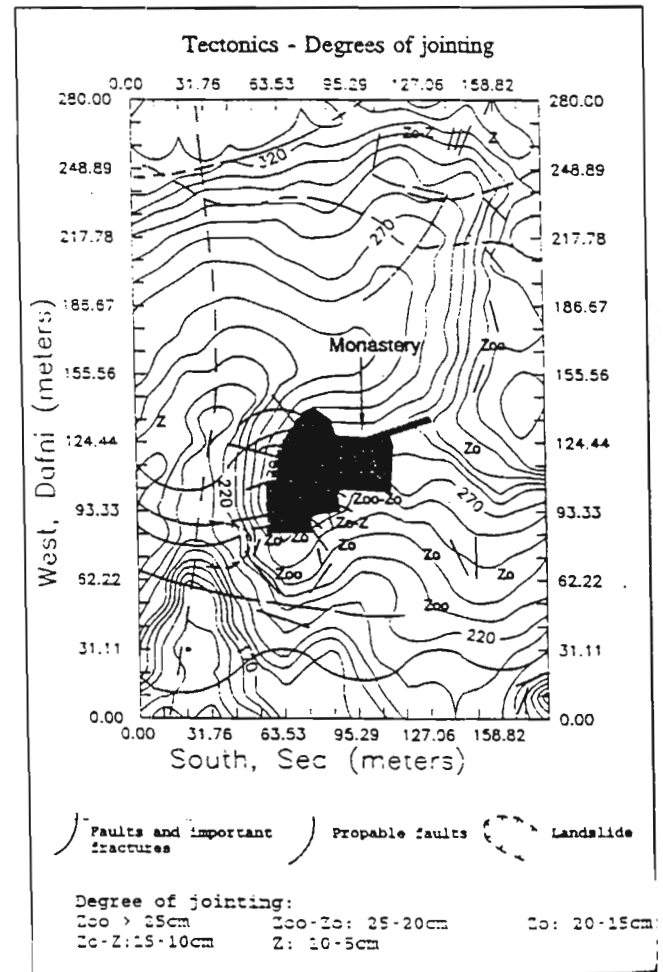
Fig. 4 - Sketch of the surrounding area with important faults and joints. Joints are expressed by the jointing degree.

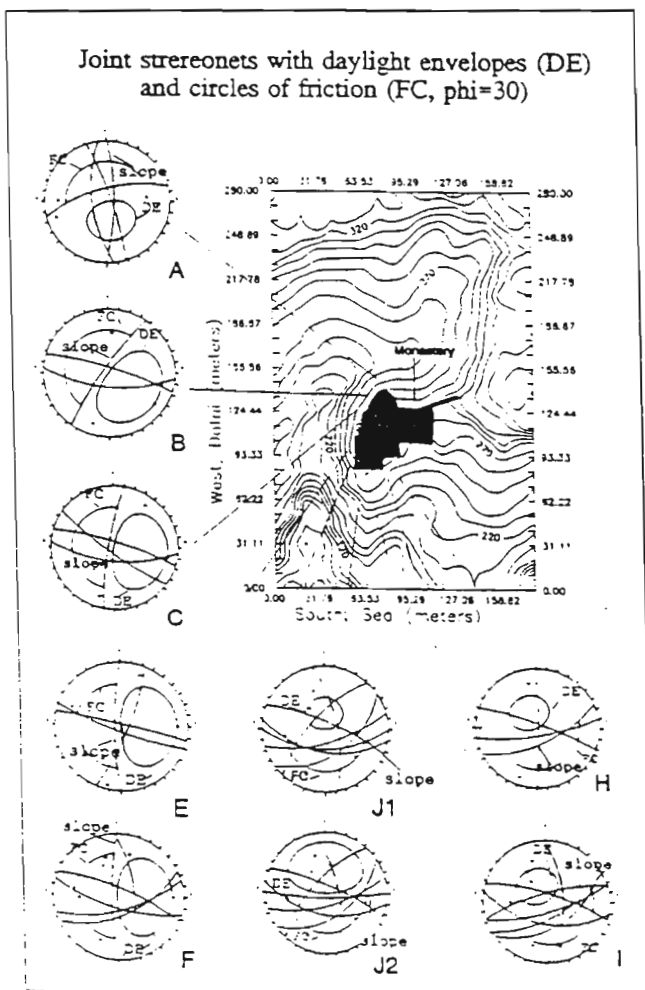
Field measurements were interpreted statistically and the results were plotted in equatorial stereonet (Fig. 5). Slope direction as well as daylight envelope (DE) of joints that rise on the corresponding slope face are given in the stereonet in order to determine plane failures. The intersections of joint sets that determine probable wedge failures, are also given for representative sites, using the tests proposed by MARKLAND (1972), HOCKING (1976) and HOEK and BRAY (1981). A friction circle (FC) with probable, general $\phi=30^\circ$ was also plotted in every stereonet for this purpose.

sliding were interpreted and the factors of safety (F) were calculated for each case (Fig. 6). According to the above interpretation, the wedges created at the points C and E of Fig. 5, on the western slope of the foundation area, gave factors of safety higher than 1 (Fig. 6). On the other hand, the factors of safety calculated for the failures determined at the points J1, J2 and I of Fig. 5, on the southern slope of the foundation area, take values from 0.48 to 0.98, creating unstable conditions in the area (Fig. 6). The factors of safety were calculated for the sec seasons, without having taken in mind the water content of the fractures, during humid periods. This parameter lower the calculated factors of safety, creating more unstable conditions, especially during winter where freezing phenomena of the water are occurred.

Fig. 5 - Plane and wedge failures at the foundation area of the monastery (Christaras & Moropoulou, 1994).

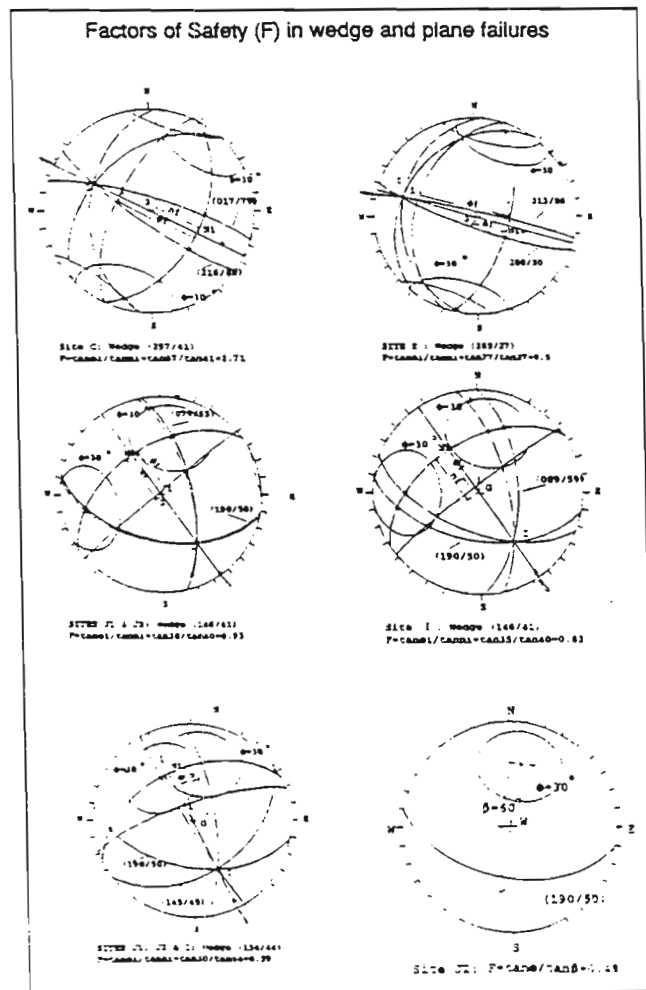
Fig. 6 - Factors of safety (F) at representative sites around the building (Christaras et al., 1994).
