Hazard assessment of a landslide reactivated in a residential area in Japan

Abstract: As urban sprawl compels more and more people to develop residences on formerly uninhabited mountain and river slopes, the question of how to estimate the landslide hazard of such areas arises. A good deal of research about this problem has been conducted in Japan, where this problem is of significant importance due to the great number of landslides that occur each year in the country. This paper will present the hazard assessment of a reactivated landslide that occurred in a residential area near the City of Kyoto. Comprehensive field and laboratory investigations were conducted to estimate vital parameters such as the geological setting of the area, the properties of soils, the rate of landslide movement, the location of the sliding surface, and the ground water level. In addition, a slope stability analysis was performed to estimate the factor of safety for the slope. Based on the results obtained remedial measures were designed.

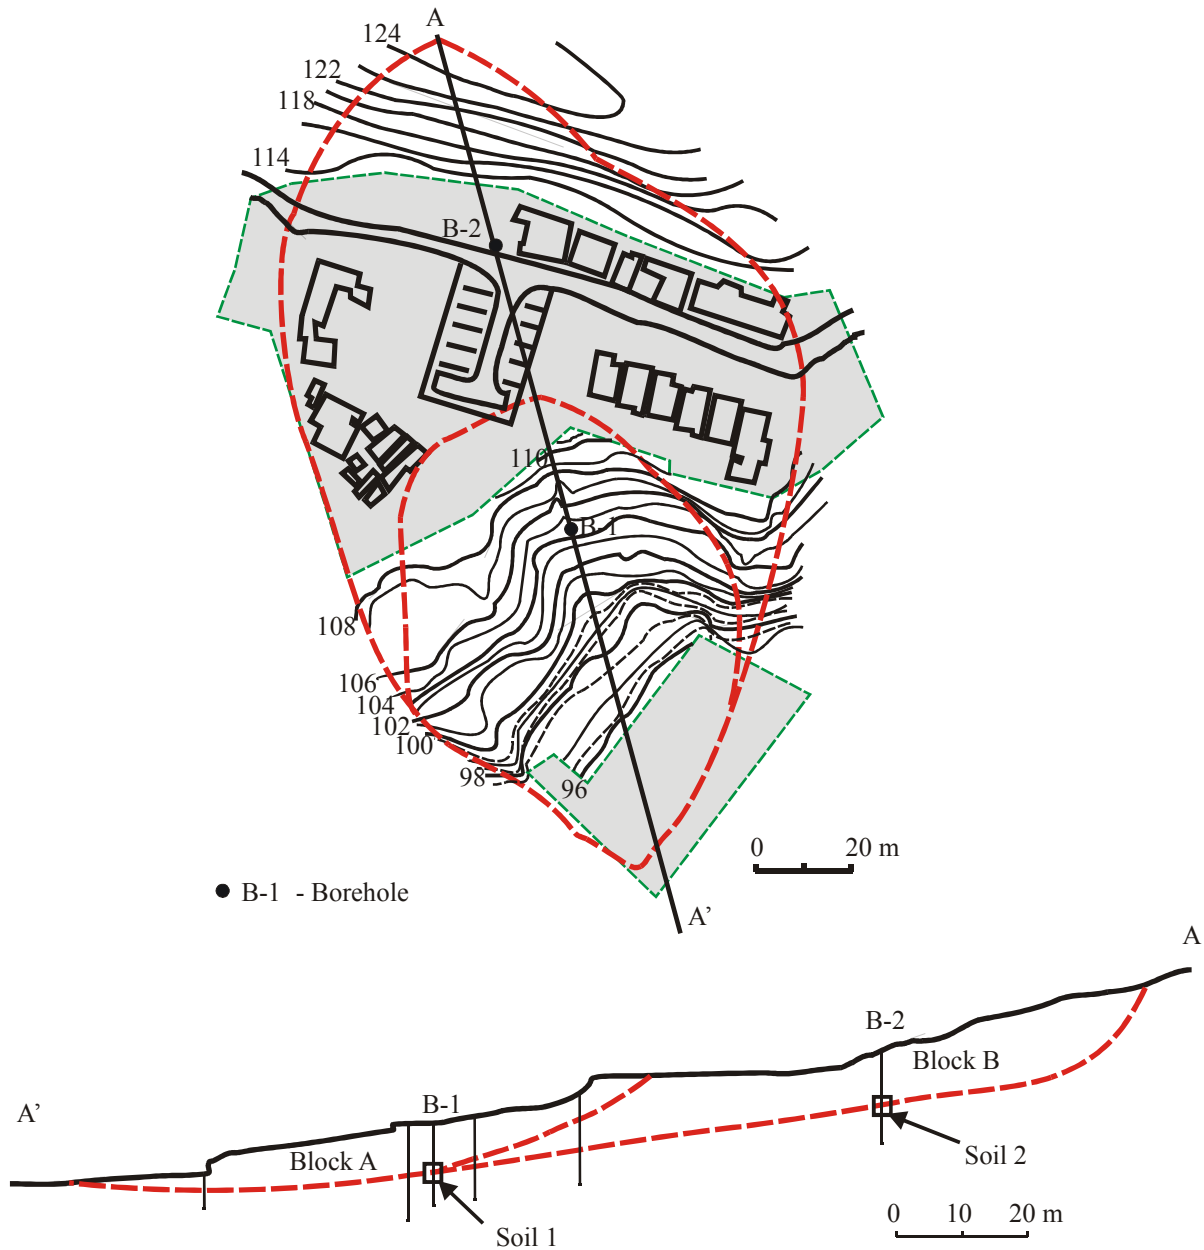
- 1) There were two landslide blocks: Block 1 and Block 2 (Figure 2).
- 2) The dip angle of the sliding surface was gentle and varied from 10 to 11 degrees.
- 3) The maximum depth of the sliding surface was estimated to be about 10 m.
- 4) The sliding velocity of Block 1 was higher (≈ 0.5 mm/month) than that of Block 2 (≈ 0.06 mm/month). Based on these results, it was assumed that the reactivation of Block 1 caused the formation and movement of Block 2.

Figure 2. Schematic plan and the cross-section (through A-A') of the studied landslide

A field investigation, including a series of boreholes, was carried out to study the geology of the landslide site. The borehole cores were collected and examined visually. Then, borehole inclinometers were installed to determine the location of the sliding surface and to monitor the direction and rate of movement of the landslide. The monitoring record revealed that:

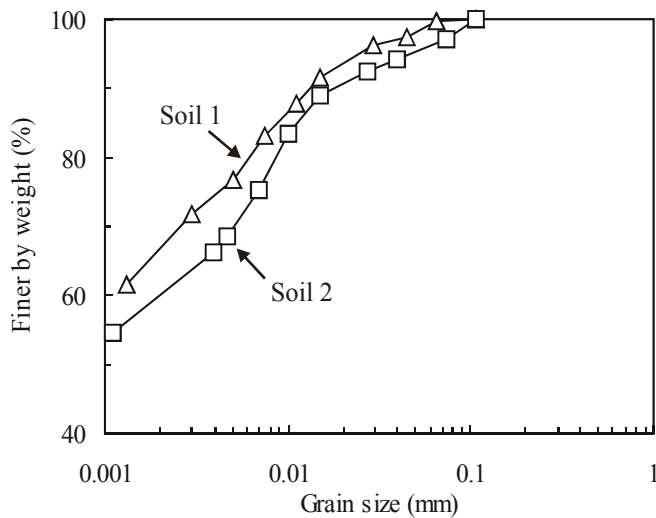
Figure 3. Grain size distribution curves of Soil 1 and Soil 2

Although the mineral composition was the same (montmorillonite, mica, kaolinite, quartz and plagioclase), in Soil 1, the clay fraction (67%) was greater than that of Soil 2 (59%), which might account for the higher plasticity of Soil 1 (PI=57.2).

To determine the geotechnical properties of the soils, a series of laboratory tests including particle size distribution and X-ray analyses, as well as the Atterberg limit analysis, were carried out. The particle size distribution curves for both soils are shown in Figure 3, while the soil's plasticity index and the mineral composition are summarized in Table 1.

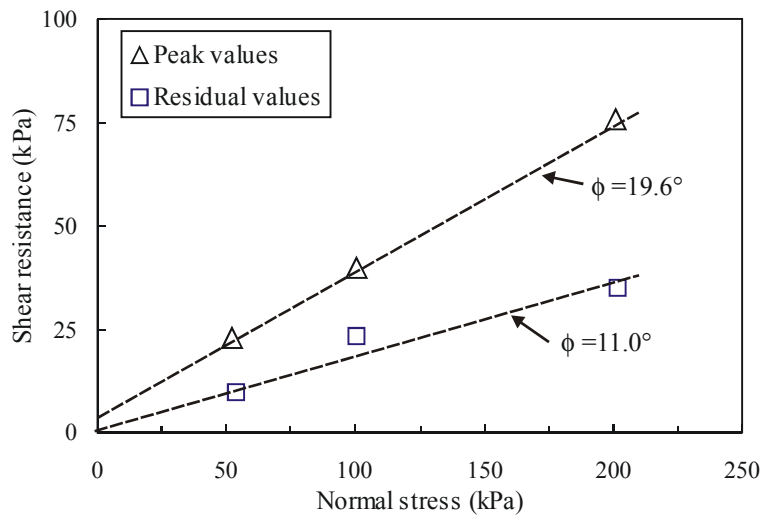
Figure 4 shows the results obtained for Soil 1. As can be seen, the value of the residual friction angle was relatively low at approximated 11.0° . The peak shear strength of this soil was about 19.6° and the cohesion was about 4.1 kPa. The residual friction angle and the peak shear strength of Soil 2 (Figure 5) were found to be higher, at 17.4° and 28.1° , respectively. The cohesion of Soil 2 was 6.6 kPa. For all the specimens formed from Soil 1 and Soil 2, the sliding surface was observed to be of a similar nature: polished with smooth striations in the direction of shear.

Figure 4. Results from drained speed-controlled ring-shear tests on Soil 1

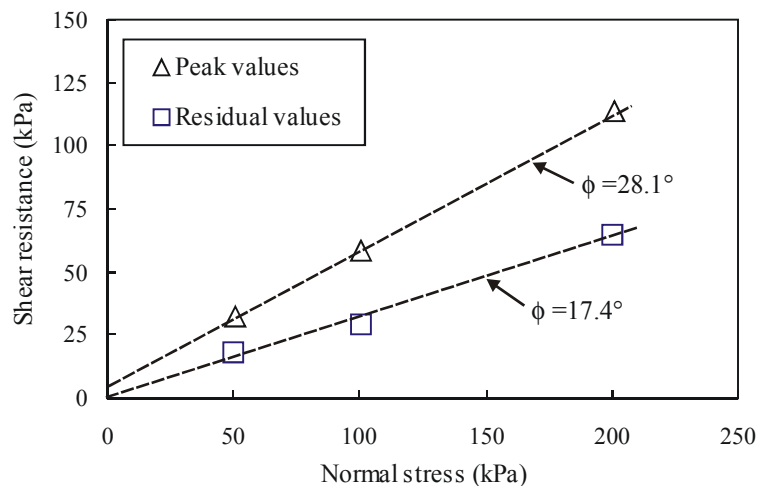
Figure 5. Results from drained speed-controlled ring-shear tests on Soil 2

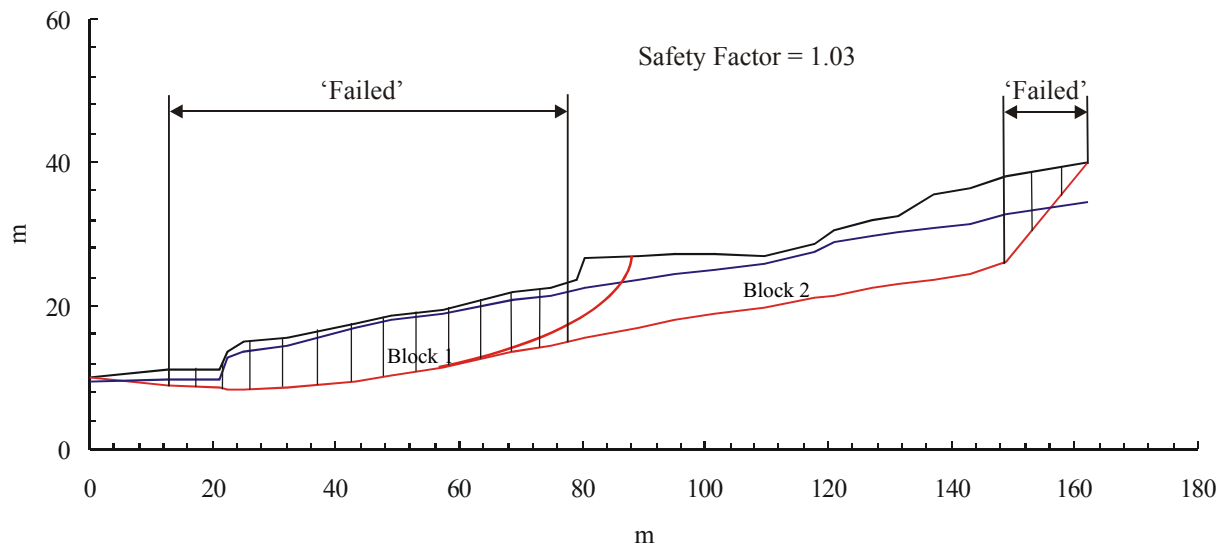
Figure 6. Results from slope stability analysis based on the progressive failure method

The results are shown in Figure 6. As can be seen, Block 1 is unstable and the local failure occurred along the sliding surface (marked as “Failed” in Figure 6), which meant that the soil resistance of Block 1 had reached its final residual value. The failure of Block 1 probably triggered the failure of Block 2. However, the soil resistance of Block 2 did not arrive at the residual state (except the top part, which is marked as ‘failed’ in Figure 6). The final safety factor was computed to be 1.03, a value that seemed to be more reasonable than that obtained from the conventional Morgenstern & Price (1965) method. In addition, the analysis facilitated a visual understanding of the mechanism of the studied landslide and explained why the sliding velocity of Block 1 was higher than that of Block 2.

A number of slope stability calculations were carried out for the studied landslide based on the limit equilibrium theory. The geometry of the slope, the location of the sliding surface, and the groundwater level were obtained from the boreholes. The calculations were performed according to the Morgenstern & Price (1965) method based on the hypothesis that the function describing the relation between horizontal and vertical forces is constant. First, the safety factor of 0.94 was calculated for Block 1 using the assumption that the residual friction angle was constant throughout the entire sliding surface and equal to 11.0° (the residual shear strength value of Soil 1 obtained from the ring-shear tests). Then, the safety factor was computed for the whole landslide, including Block 1 and Block 2, which was equal to 1.13. This value seemed to be overly high, suggesting a degree of slope safety that could be misleading. The apparent overestimation of the safety factor and the analysis of the landslide mechanism prompted the authors to use the progressive failure method (PFM) to estimate the slope stability. The principles of PFM, based on the limit equilibrium concept, were described by Law & Lumb (1976) and Tiande, Chongwu & Shengzhi (1999); thus, only a brief introduction to the method is given. The landslide body was divided into slices and the moments of forces acting on each slice were taken. The local failure was determined by comparing the shear stress due to the effect of gravity and the pore pressure which acted upon the slice, to the maximum available shear strength. If the former was smaller than the latter, the slice was assumed to be 'safe', if the former was higher, the slice was assumed to 'fail' and a local failure would begin to propagate. The inter-slice forces were calculated and the local failure propagation was estimated for the whole landslide. The final safety factor was defined as the ratio of the overall available strength to the actual shear stress acting on the slope.
