Weathering and deterioration evaluation of a Brazilian cultural heritage building

Abstract: Rio de Janeiro's Municipal Theatre building was built in an eclectic style at the beginning of the 20th century (1905-1909). Its design was inspired in the Paris Opera of Garnier and blocks of gneissic rock were used as masonry on the first floor. It has been considered a Brazilian cultural heritage since 1973.

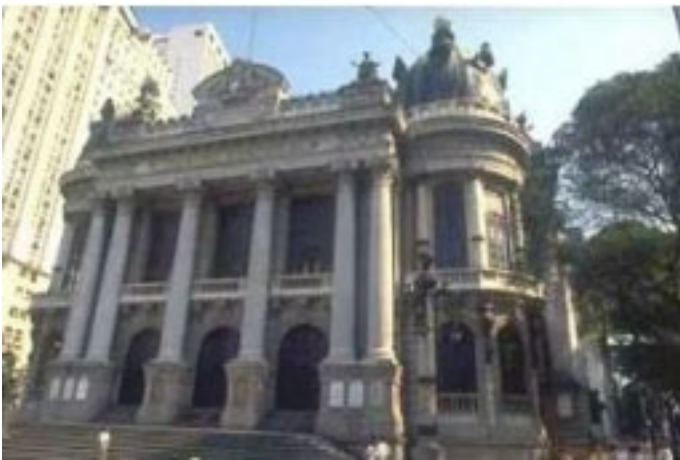
Figure 1. A view of the front side of Municipal Theatre.

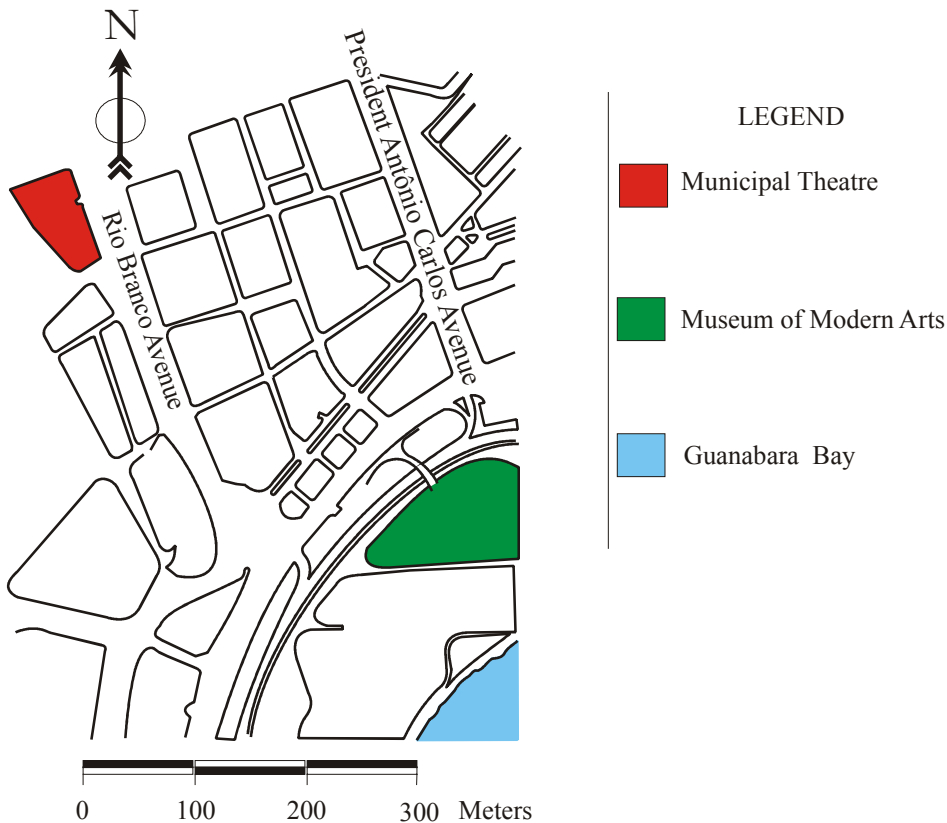
The Municipal Theatre is located beside Rio Branco Avenue, one of the most important downtown avenues in Rio de Janeiro, which has a high amount of vehicle circulation. It is 500 m far from the edge of Guanabara Bay. Figure 2 illustrates its location and the geographic orientation of the building façade.

Figure 2. The localization and the geographic orientation of the building façades of Municipal Theatre.

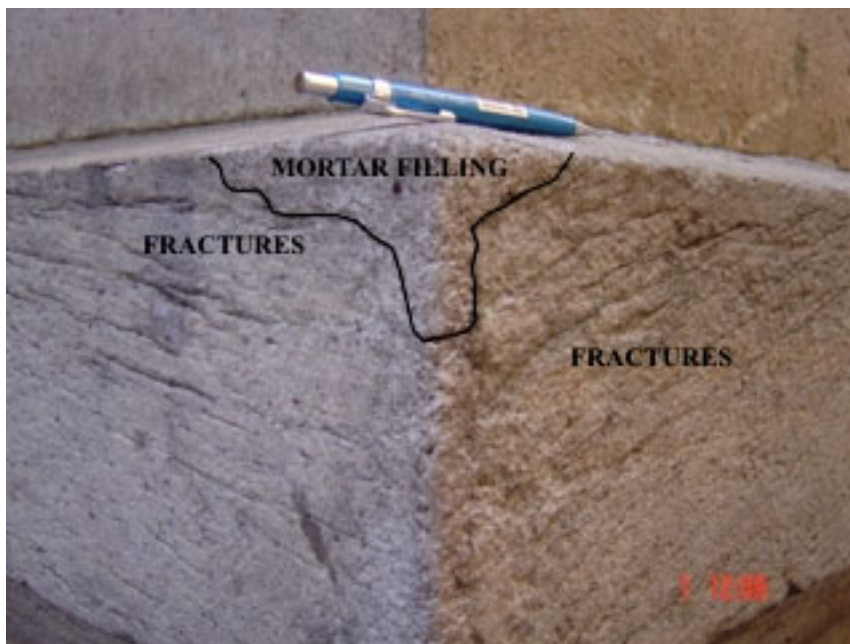
The weathering morphology is clearly controlled by the texture of the rock. It is noticeable that the formation and propagation of fractures through out the foliation occurs in the places where the gneissic foliation is more developed, producing peeling or exfoliation. Figure 3 shows it very well. It is worth noticing that this fact matches with the observations of Barroso et al. (1993) who, by studying the weathering of these same gneisses obtained from outcrops in the city, verified that the fracture propagation process began parallel to the rock foliation. When the metamorphic rock foliation gives way to a magmatic texture, the weathering morphology is revealed in a granular disaggregation, as it is exposed in Figure 4.

Figure 3. Fractures formed following rock foliation.

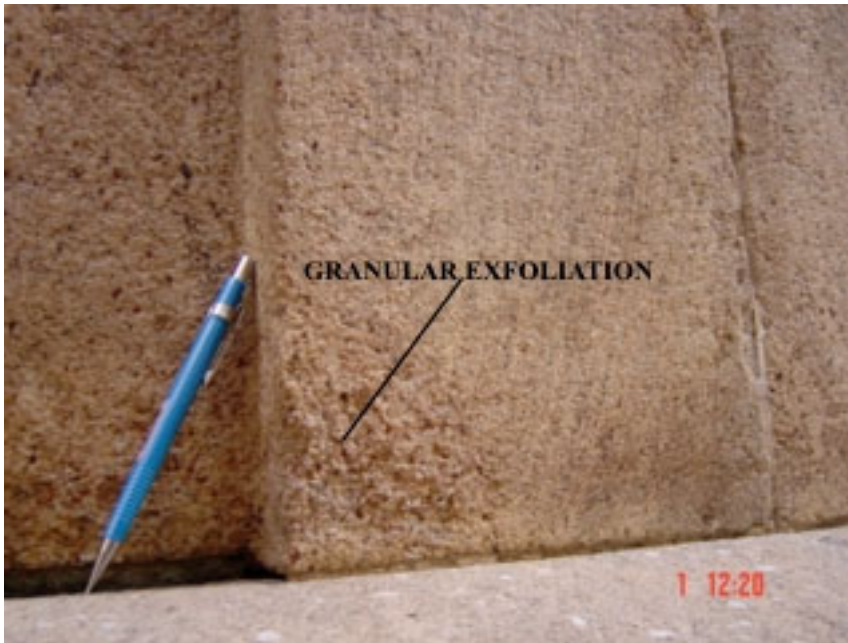
Figure 4. Granular exfoliation developed where foliation is absent.

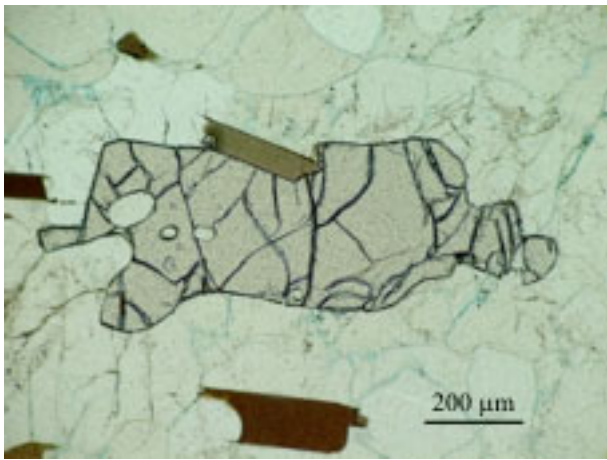
When the mineral alteration characteristics can be verified at a microscopic scale, some interesting behaviour is highlighted. Figure 5 shows a garnet with an enhancement in its internal micro fractures' shape. It is interesting to

compare this grain's outline and its internal micro fractures to tenuous outlines of neighbouring grains. This fact might be related to the precipitation of iron oxide. The biotite presents a similar feature in its cleavage, as shown in Figure 6.

Figure 5. Internal fractures of garnet become evident by iron oxide precipitation.

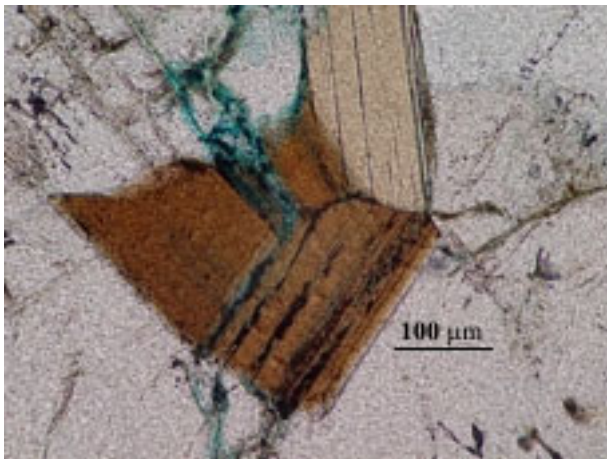
Figure 6. Biotite's cleavage marked by iron oxide.

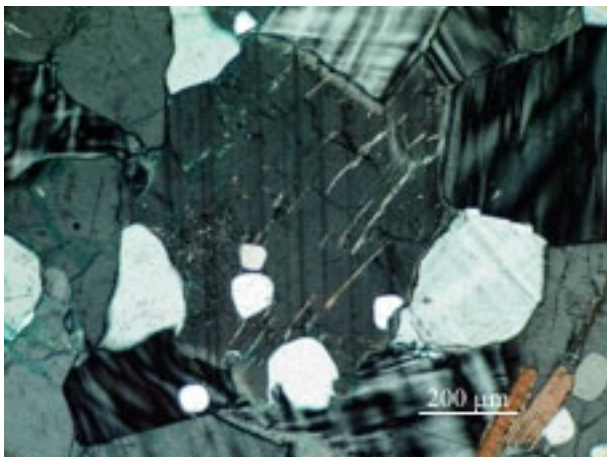
The main feature of the plagioclases' alteration is related to the formation of sericites in its surface, especially through the microcracks inside the grain (Figure 7) and also through its twin lamellae (Figure 8).

Figure 7. Sericite formation along microcracks in plagioclase.

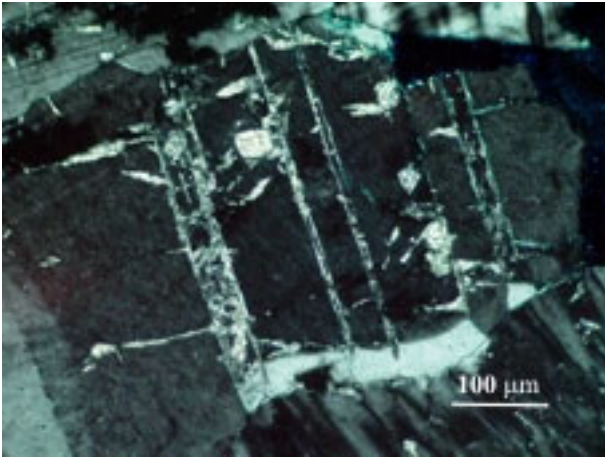
Figure 8. Sericite formation along plagioclase's lamellae.

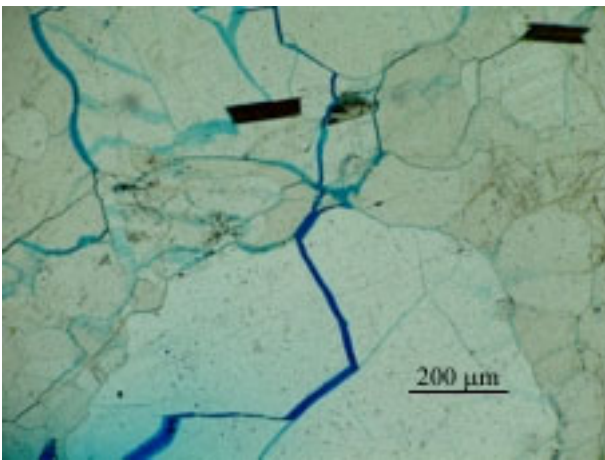
When it comes to the development of micro fractures (Figure 9), it is evident that they tend to propagate on the grain outlines (intergranular microcracks). This fact probably causes loosening to the rock matrix.

Figure 9. Presence of microcracks (blue lines) on grain outlines.

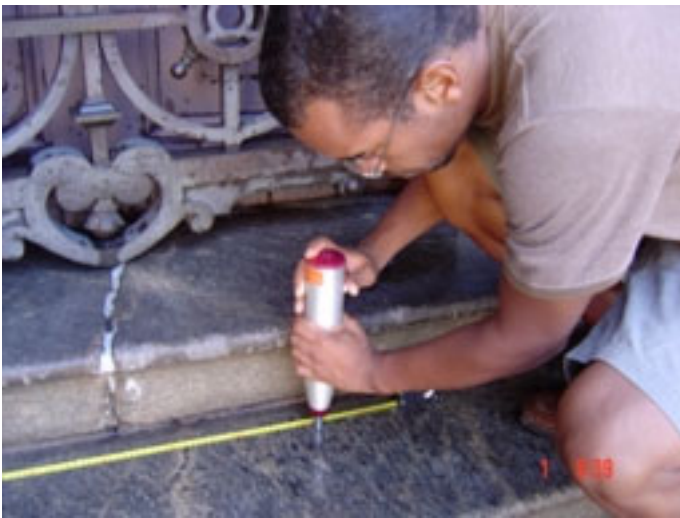
By doing this test it is possible to get to the rock superficial hardness, the Schmidt hammer index (SHI), which can be empirically related to the unconfined compressive strength. This method consists of exposing the rock surface to a uniform impact using a certain mass with a certain amount of energy, gauging the value of the rebound (SHI). The rebound depends on the value of kinetic energy before the impact as well as how much of this energy is absorbed during the impact, since part of the energy is absorbed due to the mechanical friction of the equipment, while the rest is absorbed during the contact between the percussion bar and the rock. The energy absorbed is related to the rock strength and stiffness (ISRM 1981). The tests were performed on the stairs of the theatre. The hammer was vertically positioned and a 60 mm square-shaped mesh was used, as shown in Figure 10.

Figure 10. Schmidt's hammer test being carried out on stairs of Municipal Theatre.

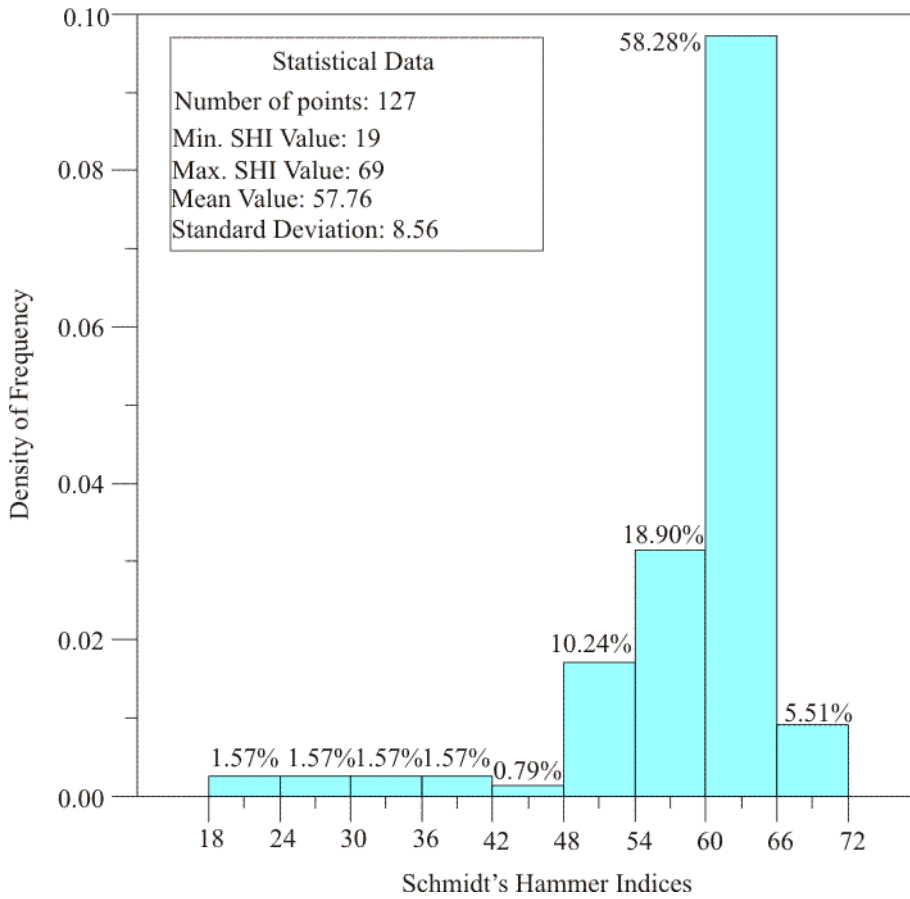
Figure 11. A typical histogram obtained for Schmidt's hammer values.

The unconfined compressive strength of the rock was calculated based on the chart presented by ISRM (1981) for L type hammers used vertically. By applying a 26 KN/m^3 unit weight to this rock and considering the mean value of the histogram in Figure 11 (SHI = 58), a value of unconfined compressive strength of $220 \pm 100 \text{ Mpa}$ is obtained.

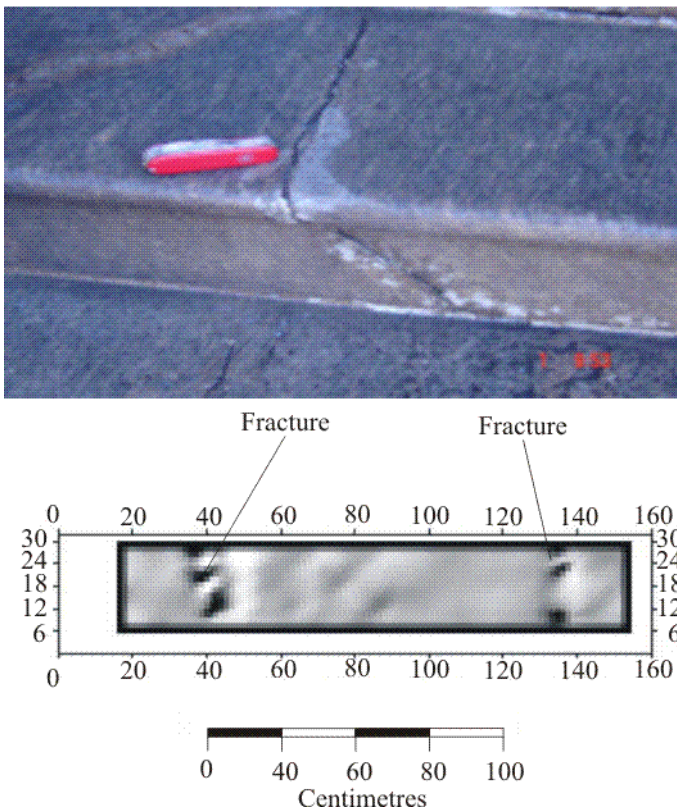
The Schmidt hammer proved to be very useful to map the rocks' fissures. This was only possible due to the fact that the values near these physical discontinuities became really low if compared with the remaining points of the rock. This investigation was held on the staircases of the Municipal Theatre and the data can be seen in Table 6. In Figure 11 there is a histogram that represents the condition of the external stairs of the Theatre. In order to map the fissures, Schmidt hammer data have been linearly interpolated on the sampling mesh. The shadow diagram presented in Figure 12 exemplifies the use of the technique on one of the steps of the staircase. The dark colours are low values of SHI and represent the presence of fractures or fissures on the rock when its distribution occurs in a stretched form.

Figure 12. A shadow chart making evident fractures on the stairs.
