The threat of abandoned mines on the stability of urban areas

BARRY G CLARKE¹, MICHELLE WELFORD² & DAVID B HUGHES³

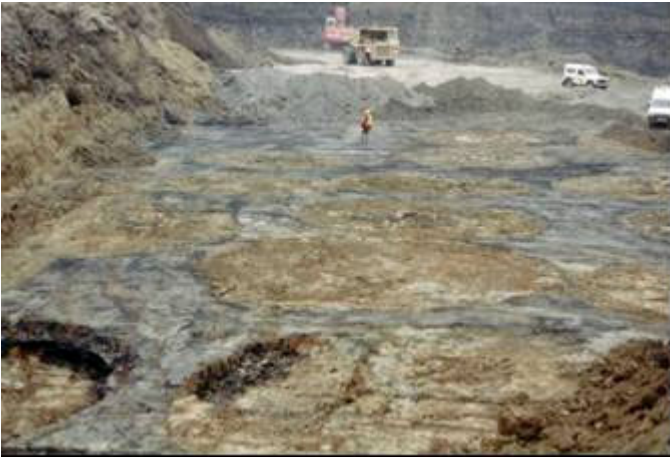
Figure 2. Bell pit workings uncovered during opencast operations at a site near Wakefield. (Photo courtesy of Carl Drury, The Banks Group).

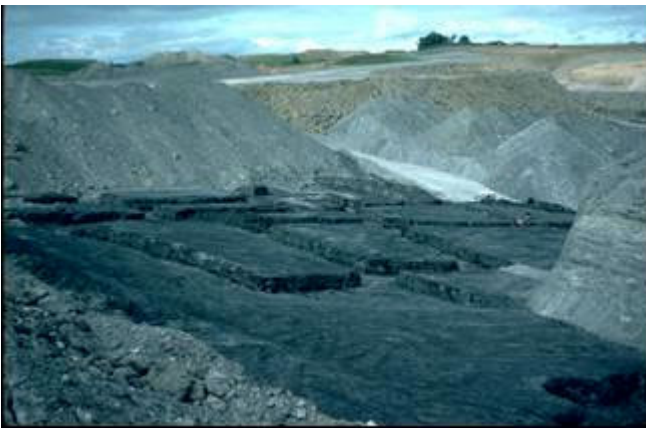
Figure 3. Room and pillar workings uncovered during opencast operations at Buckhead Site, Co Durham

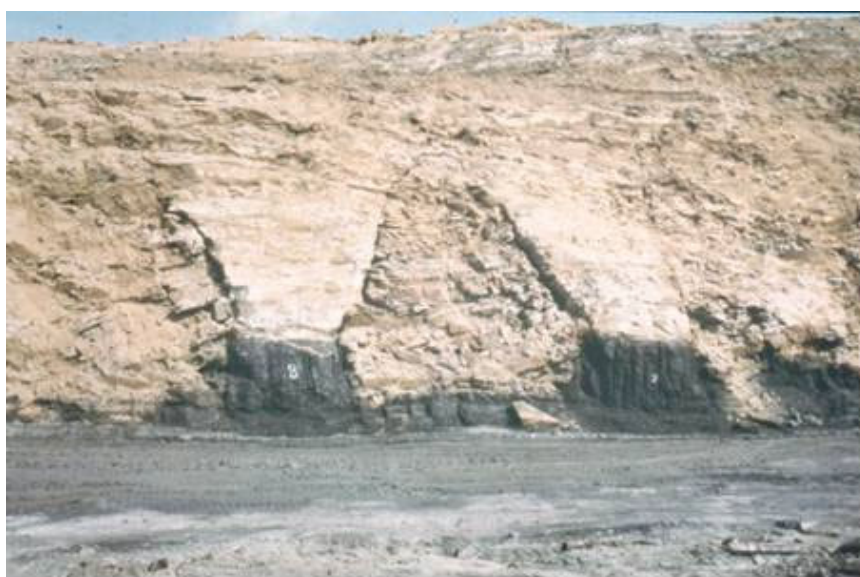
Figure 6. Crown hole collapse uncovered during opencast excavations (Photo courtesy Prof Paul Younger)

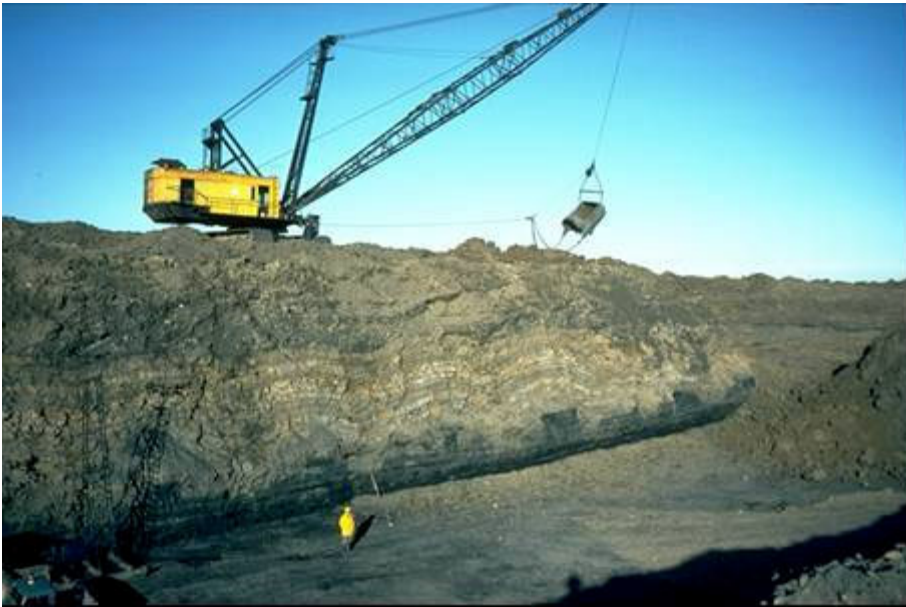
Figure 7. Creep deformation over pillars uncovered during opencast excavations at Langley site, Co Durham

Opencast excavations have revealed that there is another failure mechanism possible, that is, the deformation of the roofs of rooms over time (creep deformation), which also results in ‘areal’ subsidence (see Figure 7).

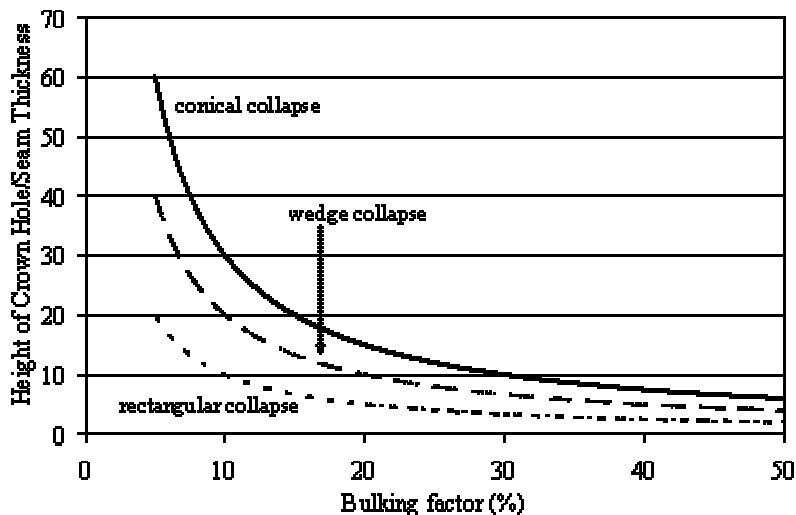
Figure 8. Extent of crown hole collapse depending on bulking factor and seam thickness (after Piggot et al. 1978)

Figure 8 shows that this corrected migration ratio is consistent with Piggot et al. (1978) theory provided the bulking factor is less than 10%. However, should pillar failure occur then the effective size of the room will increase which can result in a potential areal collapse. The hybrid mechanism, that of creep can occur whether, or not, pillars fail. That also can lead to an areal collapse.

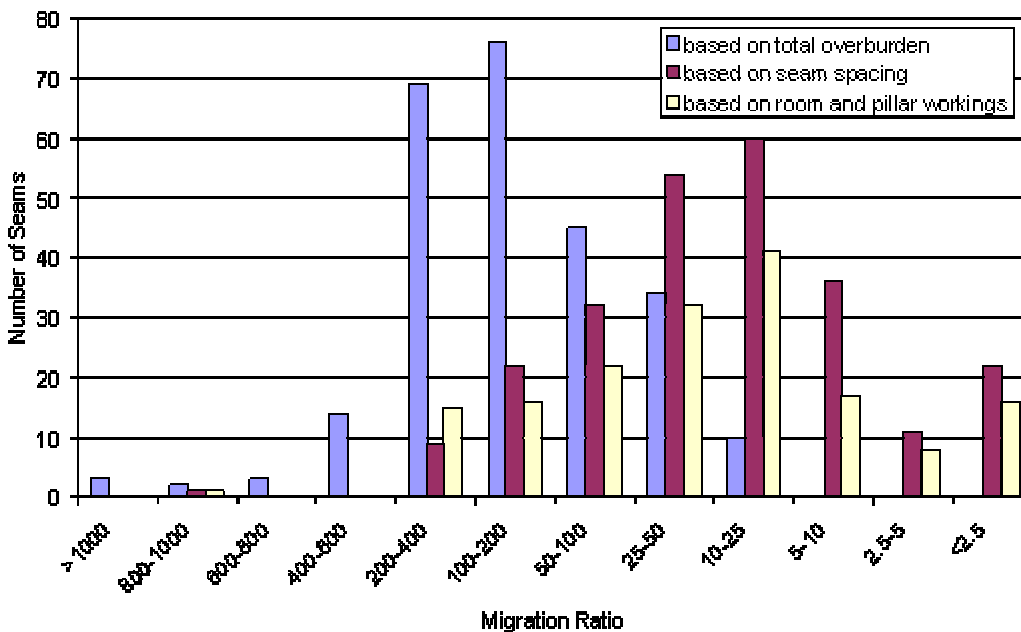
Figure 10. The Migration Ratio (for seams down to 600m below ground level and based on total overburden, seam spacing and room and pillar workings)

Ove Arup Ltd introduced the concept of the "migration ratio" as the ratio of the overburden to the seam thickness. Figure 10 shows that the ratio for sites in the Durham coalfield, where subsidence occurred, can vary from ten to over a thousand with the majority of ratios between 25 and 400. There is evidence however, that mining activity can trigger movement in other seams previously worked. In that case the migration ratio is the ratio of the distance to the next seam above the seam of interest, divided by the seam thickness. The corrected migration ratio varies between ten and nine hundred with the majority of ratios being between 5 and 100.

Modern longwall mining is designed to limit settlement. Therefore, a further correction can be applied by considering the room and pillar workings only. The distribution of the migration ratio for the room and pillar seams (discounting the longwall seams because of the backfill) is similar to that of all of the seams.
