Analysis of the deformation and failure mechanism of the Shawozi high rock slope near the Du-Wen highway

Abstract: The Shawozi high rock slope is located near a highway under construction from Dujiangyan to Wenchuan, by the Minjiang River. The terrain is steep, and the largest height of slope up to 250m. The region of interest is sited in the narrow and small crustal block between two branches of the Mao-Wen fracture zone. Random illegal blasting in mining tunnels at the toe of slope has caused the rock mass to loosen and as a consequence has produced a series of collapses and tension fractures. The construction and operation of the highway has been directly affected and as a consequence this study on the deformation and failure mechanism of the slope is required to assess the slope protection.

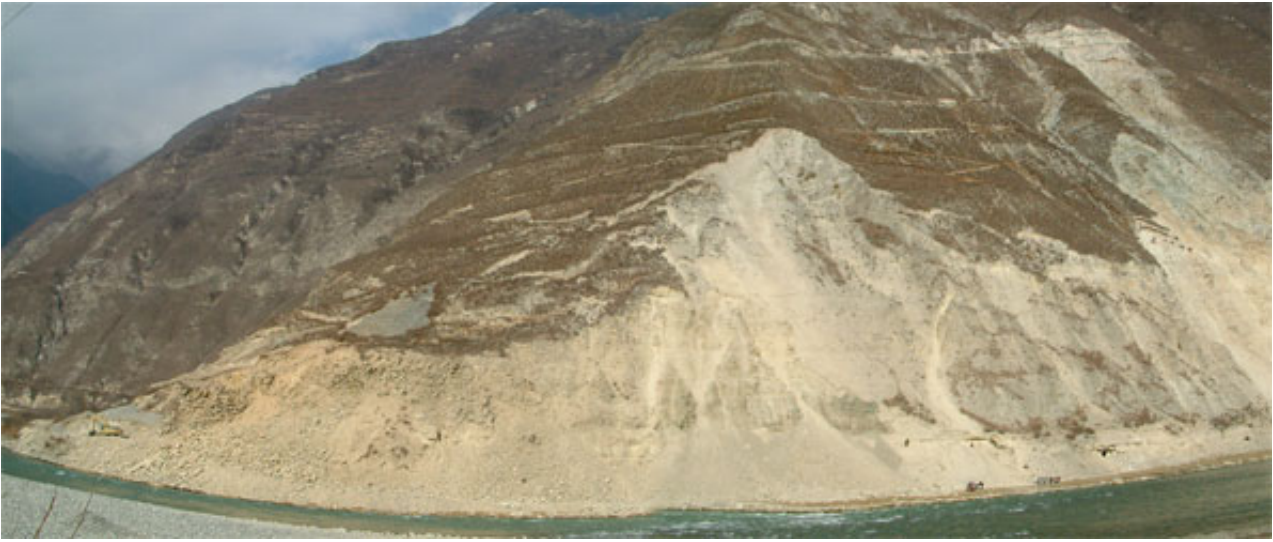
Figure 1. The photo of shawozi high rock slope

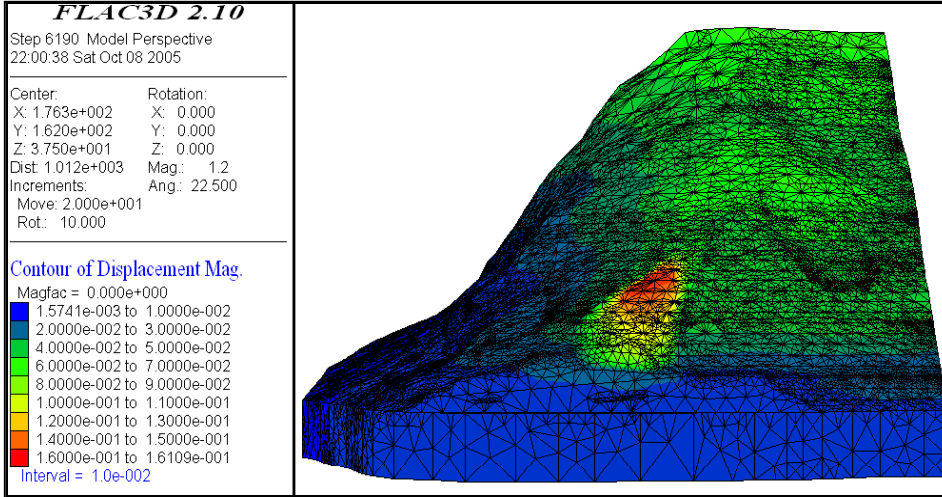
- After the construction of cutting slope on the highway, the shear stress in the landslide decreases by 0.3~0.4 MPa than one under the natural condition in XY direction; in YZ direction, it increases 0.008 MPa than one

under the natural condition; in XZ direction, the shear stress on the bottom of the back of the landslide concentrates locally, with the maximum of 0.037MPa which increases by 0.018 MPa than one under the natural condition. An additional displacement concentration phenomenon appears at the intersection of landslide mass toe and cutting slope (Figure 4~Figure 6), with the maximum values of 3cm, 8cm, and 1cm respectively. It is indicated that, after cutting on the slope, the shear stress in the landslide mass tends to decrease in XY direction, but the shear stress of landslide is concentrated locally and the displacement variation is relatively centralized, thus, the stability of the slope is greatly influenced and reinforcing the earth wall at the slope toe should be given priority consideration during the construction process.

Figure 4. The whole deformation character after cutting slope

- Slope masses in the upper 1[#] landslide and the weathering rupture rock masses on the sliding-bed surface have partly already been cleaned, but slope masses and rupture rock in the lower landslide are not suitable to excavate up. Because the cutting slope and excavation at the slope toe will accelerate the deformation of accumulations of upper landslide, meanwhile, the upper bending and deforming rock masses may further deform and then evolve into new landslide mass. In order to prevent and treat the deformation of 1[#] landslide mass and rock bed with lower part intensively deformation, the author recommended to set a prestressed anchor cable on the section K74+790~K74+900 of slope toe, or adopt stabilizing pile used in reinforcing the earth wall.

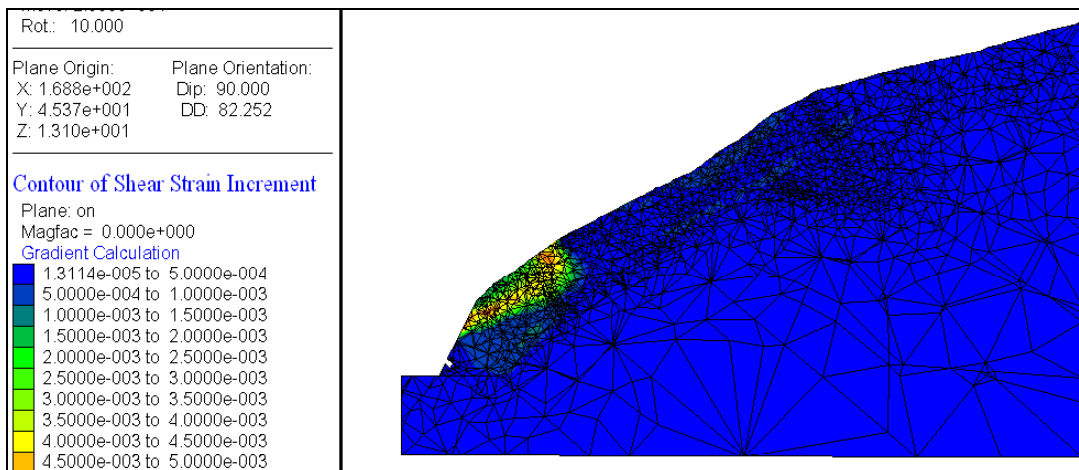
Figure 5. The strain increment character of landslide vertical section after cutting slope
