Suffosion hazard: Today's and tomorrow's problem for cities

Abstract: Suffosion is a geological hazard caused by groundwater flow. Suffosional failures (leaching, piping, underground erosion) of soils or rocks, cemented by soluble material, are well known throughout the world. The process results in a range of phenomena: weakened zones, caves and voids, subsidence hollows, collapse sinks, swallow holes, landslides and sand volcanoes. In extreme cases buildings and structures may be threatened. The catastrophic destruction in 1983 of a five-storey dwelling in Kurgan city may have been caused by suffosional processes. In this instance, the rupture of a water pipeline may have triggered the collapse, which resulted in the death of 14 persons. Although, damage to property in urban areas arising from suffosion is usually not life-threatening, an estimated 958 Russian cities and towns are thought to be affected by this process, leading to an annual repair bill estimated at about £200 million pounds. Hazardous and damaging suffosion is predominantly a man-made phenomenon, caused by development activities that fail to take proper account of the geological environment. The engineering resp

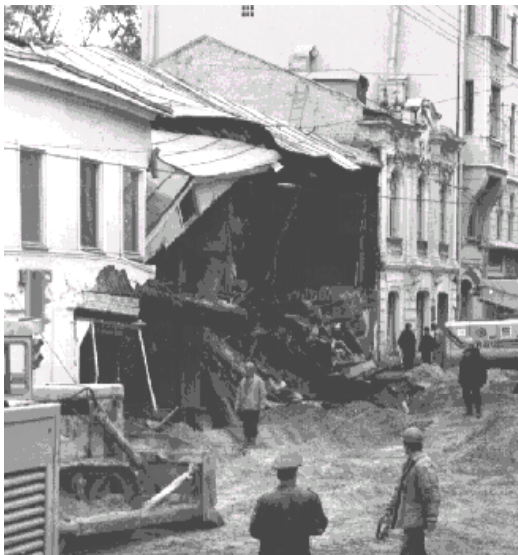
Figure 1. Destruction of building caused by suffosional collapse sink formation in Moscow in 1998

In May 1998 a suffosional collapse sink formed in Bolshaya Dmitrovka Street in Moscow. The collapse sink brought about the destruction of a two-storey building (Figure 1), which, luckily, was empty at the time. The collapse occurred because saturated sand broke into a deep underground interceptor tunnel, which was being excavated (Figure 2). According to newspaper and TV coverage of the event, as the water and the quicksand broke into the tunnel, the collapse sink diameter grew from “small” to “quite significant” in a few minutes, however, its margins did not extend to the adjoining buildings.

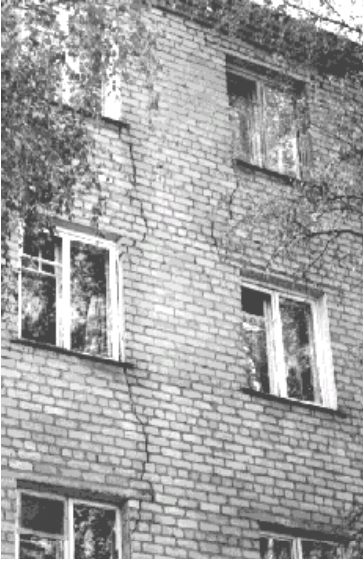
Figure 4. Deformation of house caused by suffosion subsidence in Shchyolkovo, the Moscow region, in 2002

In 2002, the appearance of damaging cracks in a five-storey block of flats in Shchyolkovo, in the Moscow region (Figure 4), prompted further investigation. The results of an engineering site study showed that the damage may have originated as a result of mechanical suffosion beneath the northwestern part of the building (Figure 5). It was suggested that infiltration of surface water through the adjoining lawns coupled with leakages from nearby sewage and heating conduits initiated the process.
