Cost effective stabilization of clay slopes and failures using plate piles

WILLIAM MCCORMICK¹ & RICHARD SHORT²

Abstract: Progressive, seasonal soil slips occurring on expansive clay slopes at a large, developed, landscaped commercial site, and in a slide-prone residential subdivision in Northern California, prompted a progressive shift from conventional slope reconstruction methods to a more innovative approach to slope stabilization. These sites have been plagued with predominantly translational soil slips on the order of 0.3m to 1m deep, that generally initiate after prolonged rainfall events, especially those in excess of 50mm/day. Based loosely on limited experimentation by researchers on similar shallow clay slips, Kleinfelder personnel expanded on their idea of installing 88.9mm-square plastic pins to designing 6.35mm (1/4 inch) thick galvanized steel, 63.5mm by 63.5mm (2.5-inch) angle iron with a 0.3m (12-inch) by 0.6m (24-inch) flange plate pile, approximately 2.1m long. Kleinfelder's (patent pending) technique utilizes plate piles laid out in a 1.2m-centred offset grid pattern. This stabilization method is being used to provide stabilization on un-failed and some existin

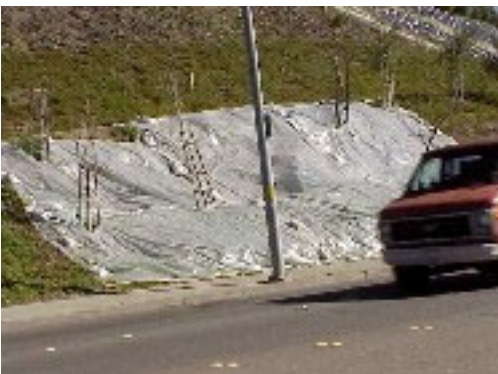
The landslides vary in depth from 0.3 to 1m-deep and range in width from 3m to several tens of meters wide (Figure 1). The failure surface is parallel to slope and the landslides are most closely described as translational earth block slides (after Varnes, 1978), with some flow deformation at the toe. Debris within the landslides typically consist of soft to stiff, wet clay (either residual/colluvial soils or clay fill), which is underlain by either stiff to hard claystone or claystone-derived engineered fill.

Figure 1. Translational landslide on landscaped slope

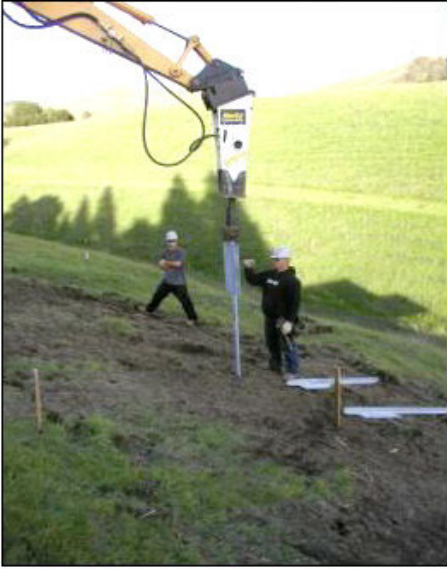
Depending on the stiffness of the underlying materials, plate pile can be installed either by direct push method by an excavator bucket or driven by either a hoe-ram or "head-shaker" compactor attached to an excavator or backhoe, equipped with a modified "cup" that fits over the end of the plate pile (Figure 4). Plate piles are sufficiently light (approximate 27kg) and can be manoeuvred and placed into position by a single labourer. Depending on site and access conditions, plate piles can be installed at rates of 20 to 25 per hour.

Figure 4. Installation of a plate pile with a modified hoe-ram attachment on an excavator

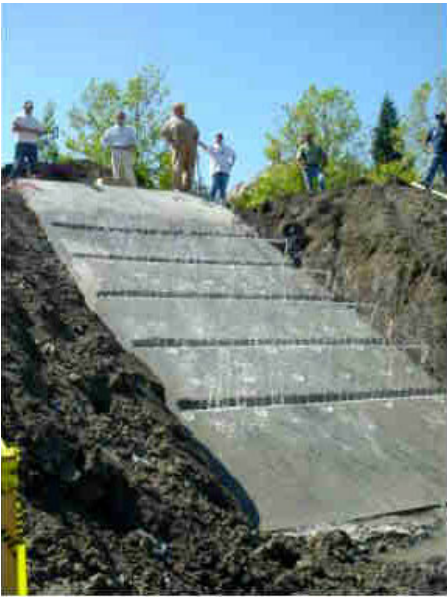
The residential test site is located within the Blackhawk gated residential development in Northern California. The slopes surrounding this development have been prone to numerous shallow landslides that have developed within residual and colluvial clayey soils, typically underlain by weak claystone bedrock. To test the effectiveness of the plate pile stability method, a series of full-scale field tests were performed at the Blackhawk Geologic Hazard Abatement District (GHAD) Test Site. Short, et al. (2005, in press) have summarized the testing and evaluation procedures that demonstrate the effectiveness of plate piles in stabilizing shallow landslides and potentially unstable slopes underlain by clay. Short, et al. (2005) experimented by constructing a 2H:1V (26.6°) test fill slope underlain by a concrete slab outfitted with irrigation lines (to simulate pore water pressure) and a geometric arrangement of PVC tubes/sleeves in which various configurations of plate piles can be inserted (Figure 5).

Figure 5. Concrete slab at test site outfitted with an array of plate pile sleeves and subsurface irrigation lines

The slab is designed to act as a predetermined slip surface or zone of weakness on which to initiate slippage. As part of the testing, a 1m thick layer of compacted clay fill was placed over the concrete slab. During the experiment, the surface was soaked (to simulate a rain event) and then the irrigation lines embedded in the subsurface concrete slab were turned on to increase the effective pore pressure acting on the base of the soil and soil/concrete interface (slip surface). The test continued in the unreinforced slope until translational failure was initiated within approximately 7 minutes. The test was then repeated, this time with plate piles inserted into the sleeves in the concrete on a 1.2m-on-center lateral spacing, in rows 3m apart. Short, et al. (2005) show that failure did not occur in the second trial, even after 13 minutes of subsurface irrigation. It should be noted that no tension cracks formed and excess water from the subsurface irrigation lines exited the slope through “piping”, without loss or movement of the soil mass. The 1.2m by 3m offset grid pattern that was shown to be stable resulted in a stabilized configuration using less plate piles than that in the commercial, further reducing the cost of stabilization by an additional 50%.
