COMPATIBLE MATERIALS FOR THE PROTECTION OF EUROPEAN CULTURAL HERITAGE

PACT 55 1998

NON- DESTRUCTIVE EVALUATION OF THE PERFORMANCE OF MORTARS ON HISTORIC MASONRIES

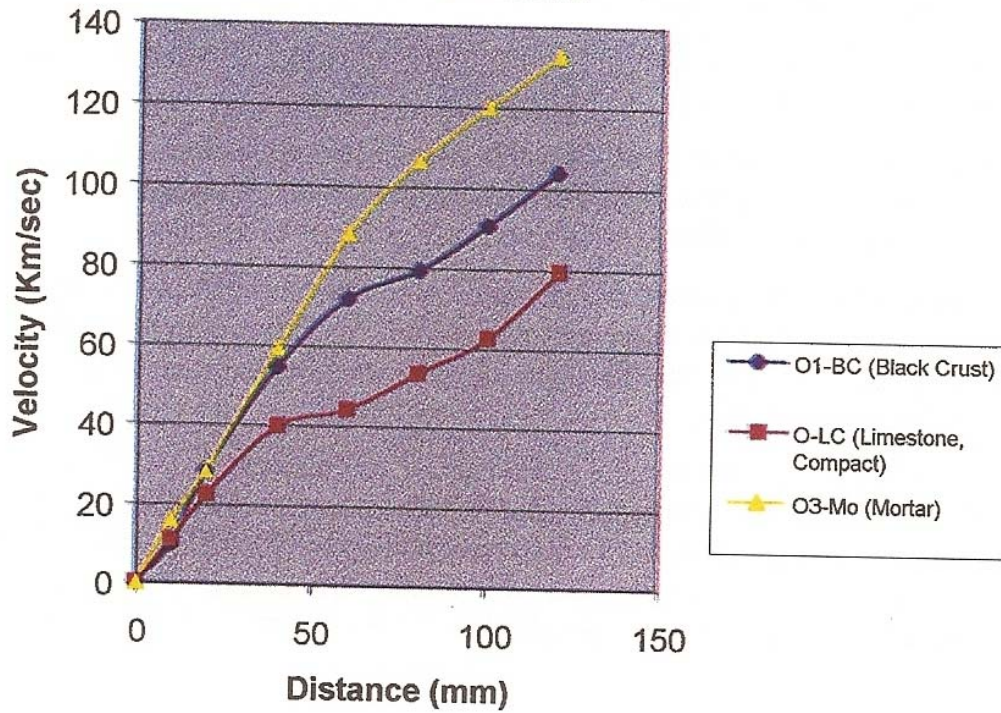
**Ultrasonic Comparative Diagram 1 - Site 1
OANAK**

The ultrasonic method can be used for the determination of the weathering depth of a mortar or a stone unit investigated on surface level. In this case, the first part of the diagrams corresponding to the exterior layer presents lower velocity until the infiltration depth. Then the velocity becomes higher, corresponding to the sound part of the building unit. Actually, at the Heraklion fortification site 1 (Vituri Bastion/OANAK) the U.S comparative Diagram 1, shows that building stones are more durable than the mortar and less weathered i.e. in smaller depth.

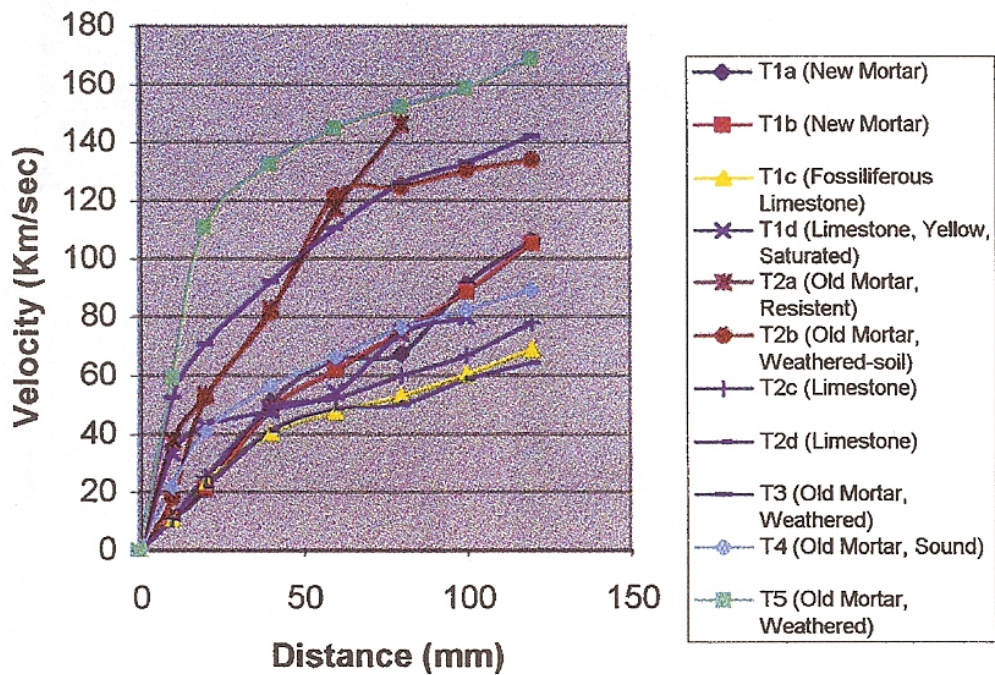
**Ultrasonic Comparative Diagram 4 - Site 5
Tobacco Cutting Factory**

Regarding Tobacco Cutting Factory, the U.S comparative Diagram 4, shows that all the old mortars at the Northern Facade present lower velocity than the new ones, at the relative layers. This is attributed to the different damage level, as well as to the most porous microstructure of the old mortars. The later, can explain the lower velocity, which is observed at the inner part, which may be characterized, as more durable. The U.S velocity regarding new mortars at the sound inner part is relatively lower than that of the fossiliferous bioclastic calcarenite, while at the weathered outer zone the velocities are more or less coinciding.

At the Western Facade the old sound mortars present velocities relative to these of the new mortars and the limestones at the inner depths. However, the weathered friable old mortars present dramatically different velocities, due to the more porous microstructures. As far as crushed-brick-lime mortars in the garden wall are concerned, they present the same velocities as lime-cement restoration mortars, as expected by their similar elastic behaviour, studied exhaustively in other works. [3]

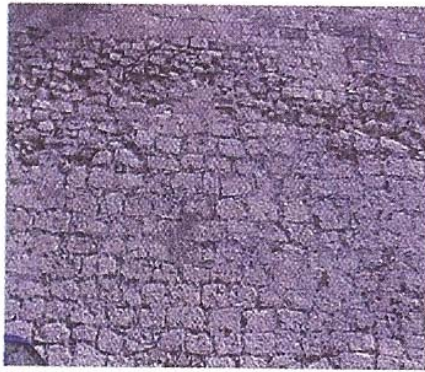
Photo 1

In figure 1 Fibre Optics Microscopy shows a masonry comprised by compact limestone (FOM 2) and of a relatively coherent but more porous old mortar (FOM 1). Actual interventions by cement-restoration mortars are observed even macroscopically.

- On the Venetian fortifications of Heraklion. The surfaces under investigation were related to previous sampling and analyses performed on the building stones and mortars [22] at the Vituri (Fig. 1) and Bethlehem (Fig. 3) Bastions and at the fortification masonry facing the National Stadium (Fig. 2).

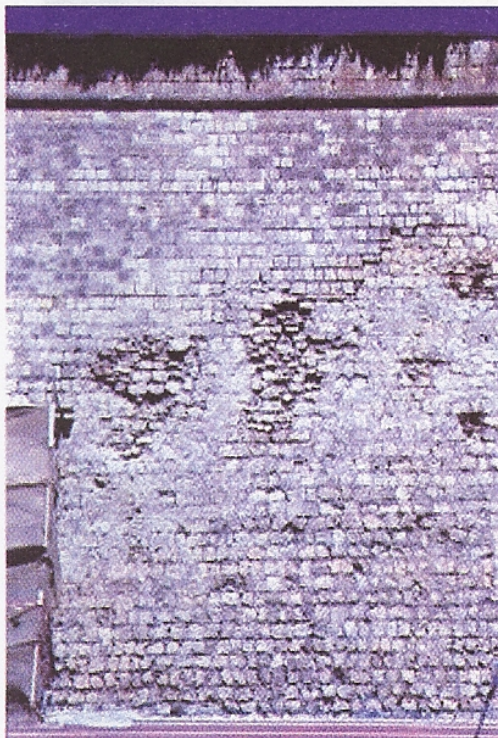
Photo 3

Along the height of the masonry - Thermal Image 4 - presents the evaporation zone, where salt solution's evaporation and crystallization promote massive disaggregation at a certain height (~2/3 of the wall - Natural Photo 3). At this part, Thermal Image 4 distinguishes the various damage levels by different colours: the more deep parts with colder ones and the outer with hotter. Disaggregated old mortars behave in the same way, while at the outer part of the masonry (Thermal Image 5), new cement restoration mortars are discerned by hot yellow lines.

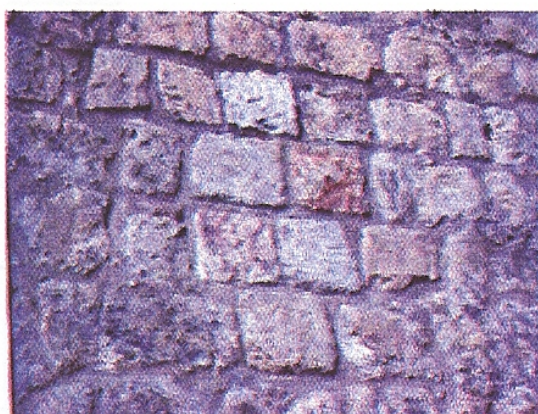
FIGURE 3 - SITE 3 - BASKETBALL COURT (IRAKLIO, CRETE)

In Figure 3 the new mortars (FOM 6) are observed in the Thermal Images 6 and 7 - rendering the Natural Photos 4 and 5 - by hotter colours (violet to yellow), as compared to the colder ones of the stones, indicating an incompatible percolation by soluble salts.

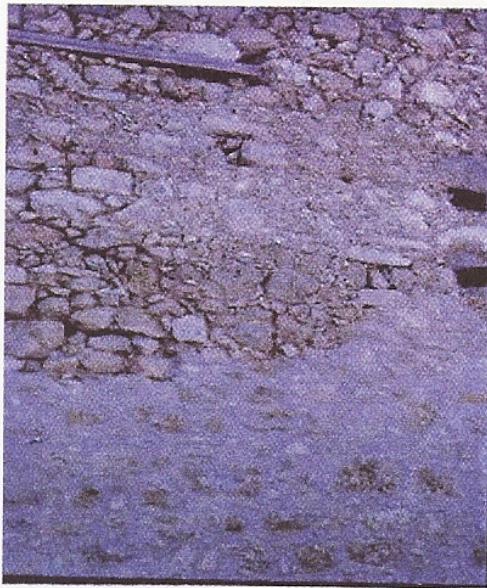
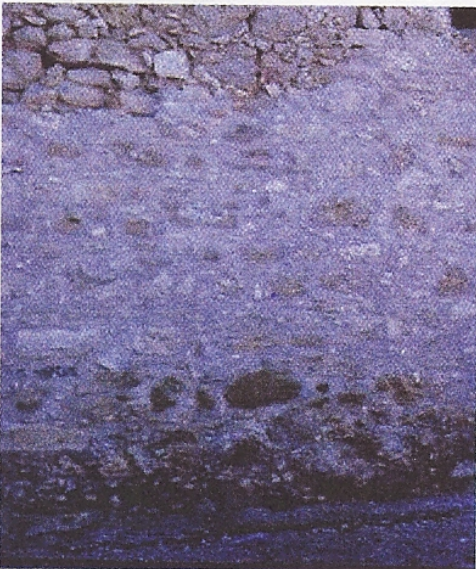
Photo 6 (bottom), 7 (up)

- On the recent industrial monument (19th c. AD) of the Tobacco Cutting Factory situated in the center of the historic Heraklion market nearby the seaboard. More specifically, the Northern (Fig. 4 north-western, Fig. 5 Northern Facade on the center) and the Western Facade (Fig. 6) were examined, as well as the garden wall surface (Fig. 7).
