## Effectiveness of *in situ* P-wave measurements in monuments. Examples from Greece

### Abstract:

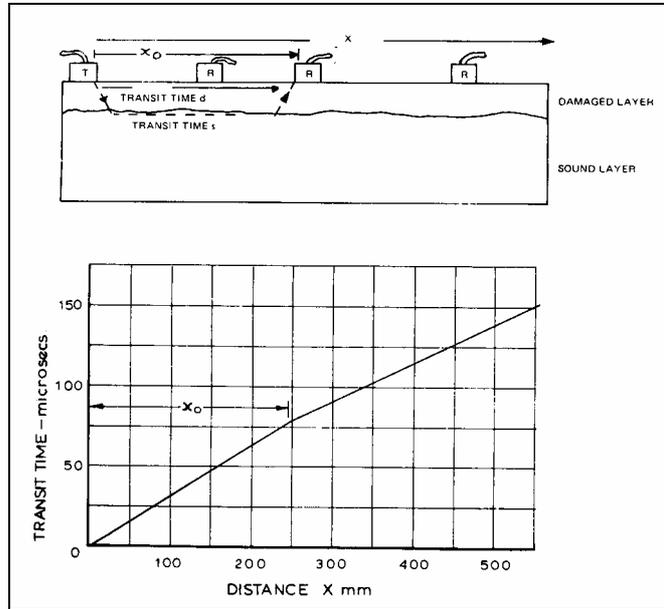
Figure 2. Diagram showing the depth of the damaged layer(PUNDIT Manual<sup>5</sup>)

The depth of weathering at a stone surface can be evaluated using the indirect ultrasonic velocity technique (Christaras<sup>1</sup> Zezza<sup>7</sup>). In this case the transmitter is placed on a suitable point of the surface and the receiver is placed on the same surface at successive positions along a specific line. The transit time is plotted in relation to the distance between the centres of the transducers. A change of slope in the plot could indicate that the pulse velocity near the surface is much lower than it is deeper down in the rock (Fig. 2). This layer of inferior quality could arise as a result of weathering.

The thickness of the weathered surface layer is estimated as follows (Fig. 2):

$$D = \frac{X_o}{2} \sqrt{\frac{V_s - V_d}{V_s + V_d}}$$

Where  $V_s$ : Pulse velocity in the sound rock (Km/s)  
 $V_d$ : Pulse velocity in the damaged rock (Km/s)  
 $X_o$ : Distance at which the change of slope occurs (mm)  
 $D$ : depth of weathering (in mm)

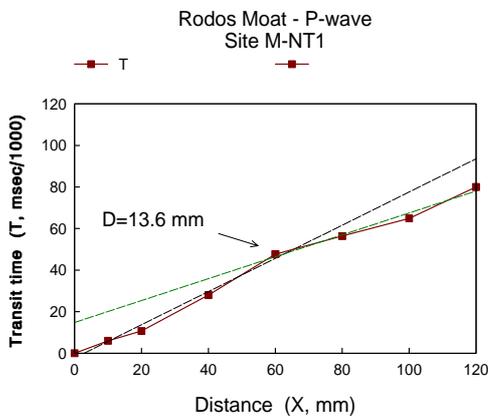
Figure 3. Ultrasonic velocities measured on untreated surface of calcarenitic blocks. The change of the regression slope corresponds to the depth of the weathered zone.

This application was performed on the walls of the Medieval City of Rhode and some representative results are presented in the diagrams of Figures 3 and 4. These diagrams correspond to measurements on two neighbouring sites at the moat of the Medieval City (Figs. 5, 6).

Comparing the diagrams of Figures 3 & 4, a higher velocity is realised at the external layer of the stone, after treatment, corresponding to the consolidated zone. An intermediate, non-treated - damaged zone is also observed. The evaluation of the thickness of this zone depends on the spacing of the successive points of measurement. However, the displacement of the regression line is directly related to the thickness of the non-consolidated – damaged zone.

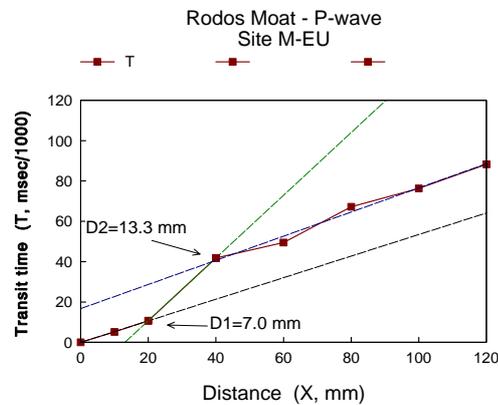
Figure 4. Ultrasonic velocities measured on the surface of calcarenite blocks, treated with consolidation liquid. The change of the regression slope corresponds to both consolidation and weathering depths.

Consequently, a full consolidation procedure corresponds to a linear (without displacement) diagram (distance / time).

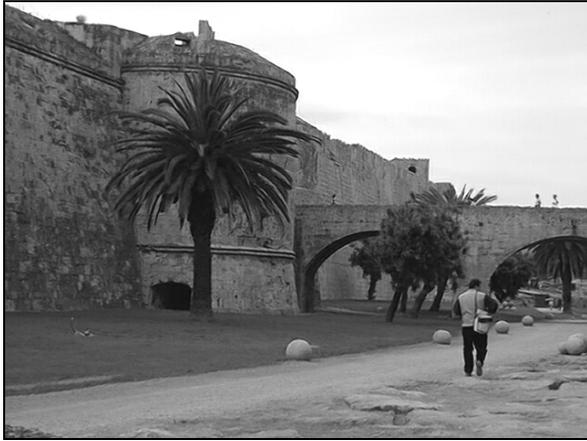
Figure 5. The moat around the medieval city of Rhode, where the tests of Figures 3 & 4 were performed

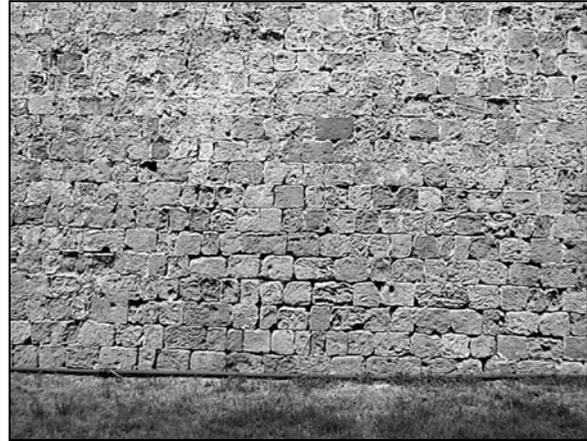
Figure 6. The calcarenite blocks where the measurements of Figures 3 & 4 were performed

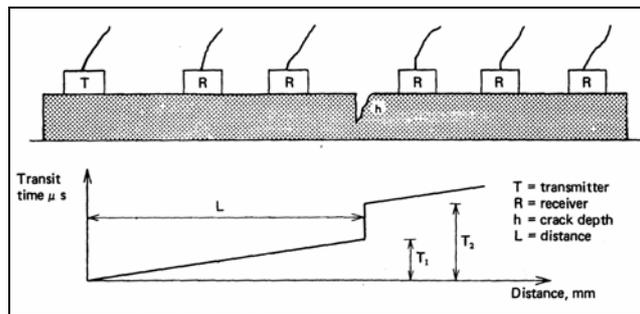
Figure 7. Diagram showing the depth of a crack, on the surface of a stone (PUNDIT Manual<sup>5</sup>)

The arrangement of the transducers at the same surface of a stone, but from the opposite sides of a crack can be used for estimating the depth of the crack. In the obtained diagram, a displacement of the regression is occurred, due to the depth of the crack (Fig. 7). This depth is estimated using the following equation:

$$h = \frac{L}{2} \left( \frac{T_2}{T_1} - \frac{T_1}{T_2} \right)$$

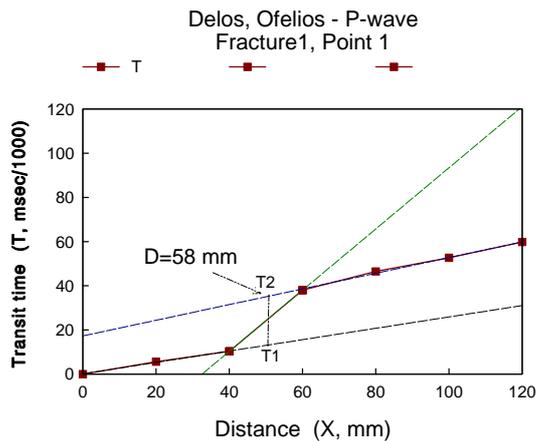
Figure 8. Ultrasonic velocities diagram on the surface of Ophelios marble statue (Delos island, Greece), for estimating the depth of a crack along its left leg.

In the diagram of Figure 8, the depth of a crack was calculated along the leg of the statue of Gaios Ophelios in Delos Island (Fig. 9).

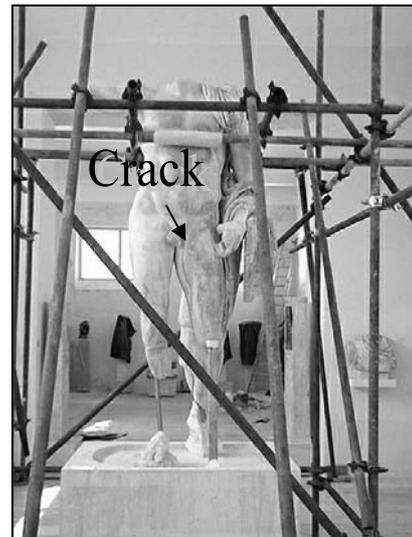
Figure 9. Gaios Ophelios statue, in Delos island (Greece)
