Slope Instability at Olympia Archaeological Site, in S. Greece

Keywords: Landslides, Monuments, Olympia

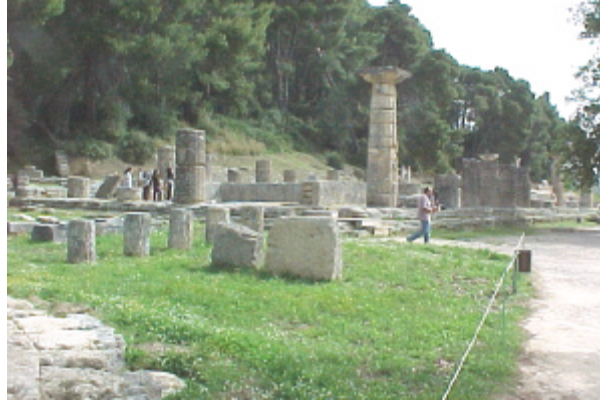
Figure 2. Part of the archaeological site

The archaeological site is limited to the north by a steep hill slope, which is crossed by a national road of heavy traffic (Figure 2). The slope consists of marls of Pliocene where many landslides occur (IGME, 1983, Figure 3).

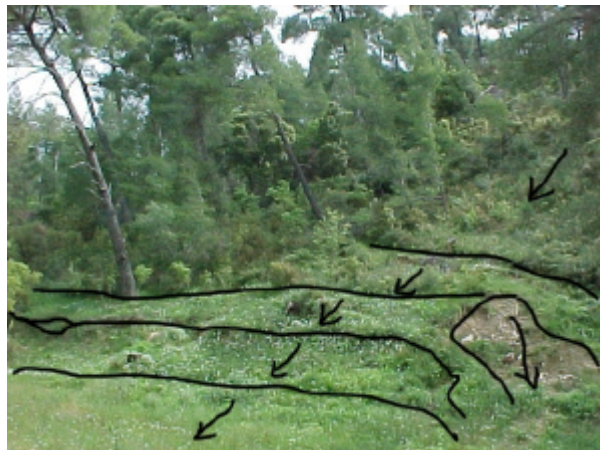
Figure 3. At the slope, over the road, landslide phenomena are occurred

It is well known that erosion caused by running water or ground water and gravity is the more significant factor for the creation of landslides on unprotected slopes. The ground water decreases the shear strength of the material in an important depth, causing earth mass movements. The uncontrolled seepage of ground water, infiltrated through the joints of an impermeable silty or clay formation, also strengthens the ability of the slope for sliding (Vuillermet et al., 1994). In cases where these formations are overlain by hard rock layers, the erosion of silts and clays causes caving at the toe of these overlaying hard rocks creating toppling or sliding phenomena. Drainage is therefore critical to the stabilization of a slope. Removal of trees, with big roots, which involve to the destruction of the ancient retaining wall, strengthens the above process.

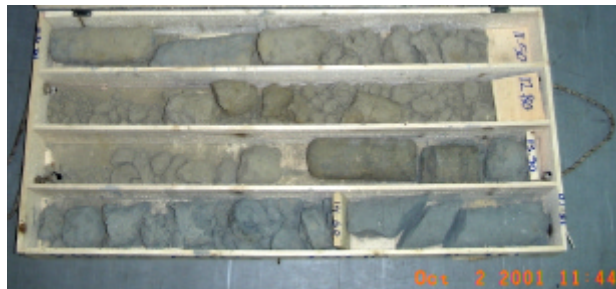
Figure 5. BoreHole samples from Olympia (sound marl: deeper than 13.80 m)

At the lower part of the hill, 10 m higher than the level of the archaeological site, a coring borehole, of 25 m deep, was constructed on the marly slope, in order to give us core samples for laboratory tests (Figure 4). According to those tests, the material was classified as silty clay to silty clayey sand of low plasticity.

According to the grain size analysis of representative specimens, the material is composed of 22-17% clay, 43-80% silt and 35-3% sand. The liquid limit (LL) of the above specimens is 30-32%, the plastic limit (PL) is 22 and the plasticity index (PI) is 8-10%. The material presents low permeability and drainage ability. In dry conditions the material is compact, having uniaxial strength of 5-15 MPa. According to the performed triaxial tests, the cohesion is 17-23.7 Kpa and the angle of internal friction is $5,2-11^{\circ}$. In rain conditions the material saturates rapidly, providing unstable conditions and important earth pressures on the ancient rocky retaining wall which lean downslope, under the pressure (Figure 5). The material of the slope is similar to that of Eptachori slope area, geologically located in the molassic formation of the Messoellenic Basin of N. Greece. (Christaras, 1997)

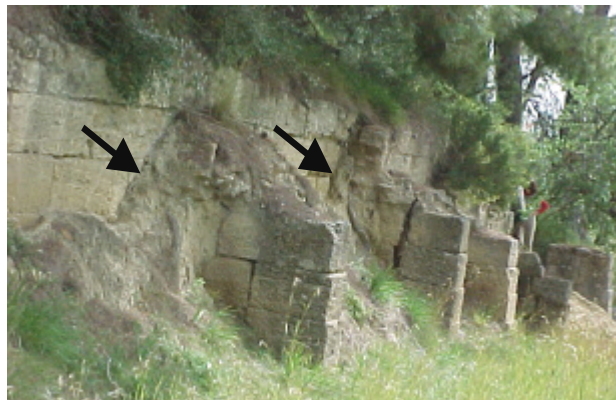
Figure 4. Destroyed ancient retaining wall

The instability of the slope is mainly related to the quality of the material, as it was previously described. Nevertheless, the root system of the big trees and the drainage incapacity strengthens the instability of the slope, especially at the lower parts, near to the archaeological site and create important earth pressure on the existed ancient retaining wall.

For this reason a retaining system, of that lower part of the slope, could not be totally safe without a sufficient drainage system to be applied and measures for removing the roots of the trees to be taken.

The support of the slope, using modern slope retaining or ground improvement methods, cannot be applied without taking into account that they have to be adapted to the ancient environment.
