Brief report of the 2016 Kumamoto Earthquake in JAPAN

IAEG Japan National Group (Japan Society of Engineering Geology)

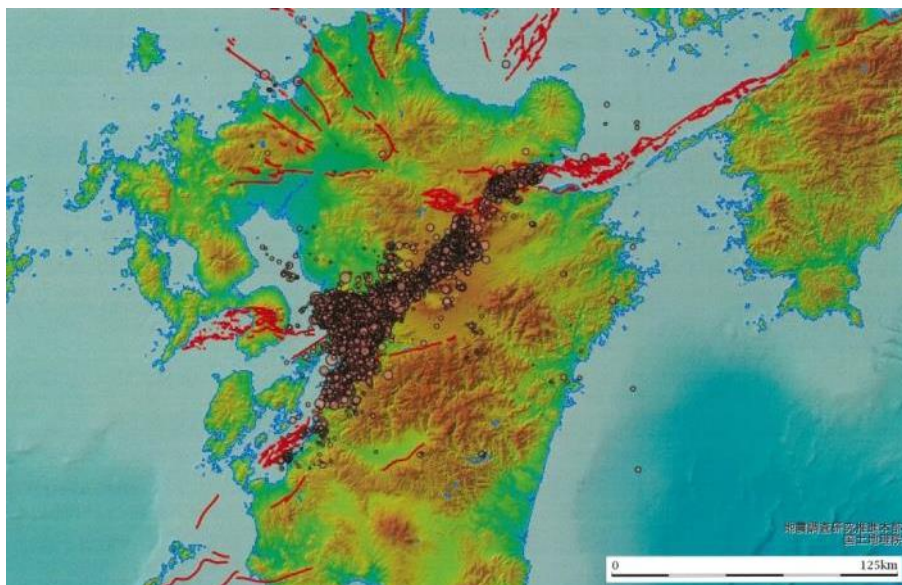
Fig.4
 Distribution of the epicenters since April 14 2016
 (At May 10, 14:46)

The epicenters of the Kumamoto earthquake and aftershocks since April 14 are distributed SW-NE direction along the southern edge of the Beppu-Shimabara rift zone. (Fig.4) It was reported that the type and the focal depth of main earthquakes were lateral slip type faults and about 10 km respectively.

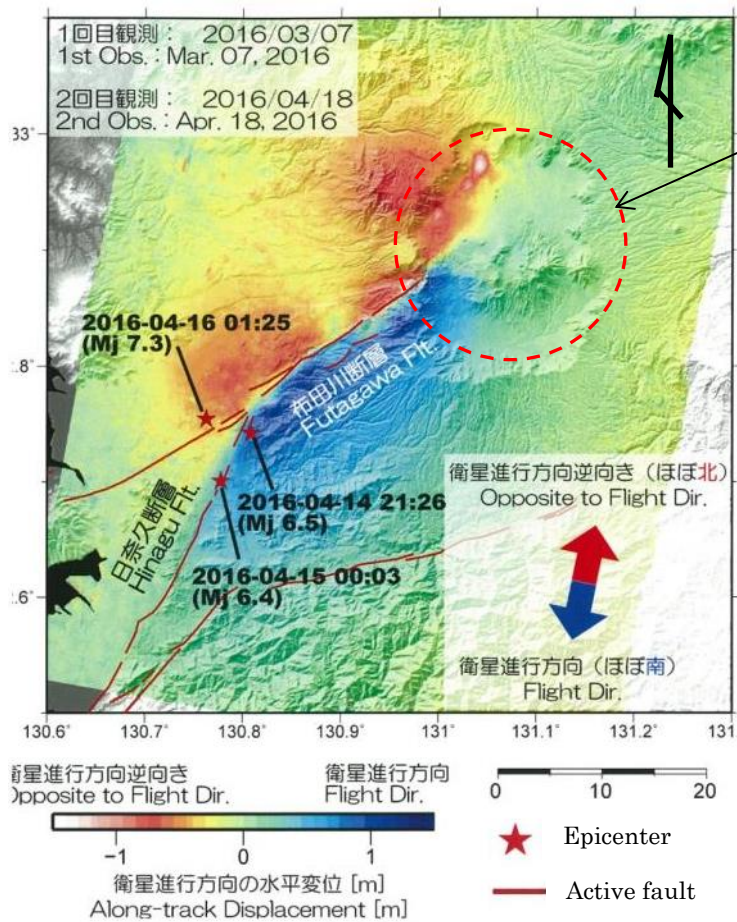
Fig.5 MAI (Multiple Aperture Interferometry) analysis using ALOS-2/PALSAR-2

There are two right lateral active faults, Hinagu fault and Futagawa fault near Kumamoto City. According to the analysis of the surface movement by MAI (Multiple Aperture Interferometry), right slip movement along these faults are clearly shown. (Fig.5) And surface faults along Futagawa Fault with right lateral slip displacement of maximum 2 m were observed. (Fig.6)
