# The stability of a large slope after impoundment by using 3D numerical modeling at the reservoir

**Abstract:** For the stability of large reservoir slopes after impoundment it is very important to correlate all factors which affect the dam's safety and its usage. If destabilization occurs, it will do harm to the thousands of people who live up the slope. The results from using 3D numerical modeling indicate that there are three failure planes in the slope, that is, there is a major failure plane and two secondary ones. The connectivity of the major one is low and for the others it is high, so the slope as a whole is stable but it may partially fail when the impounded water level reaches 1880m. The results also indicate that its deformation is small and it is wholly stable in the initial stage. As the impounded water level rises, so deformation increases. There is large scale local deformation or damage when the impounded water level reaches 1850m. The deformation and damage become greater and wider possibly leading to partial failure when the impounded water level reaches 1880m. However, on the whole, it is still stable, and it is a middle-superficial layer slope.

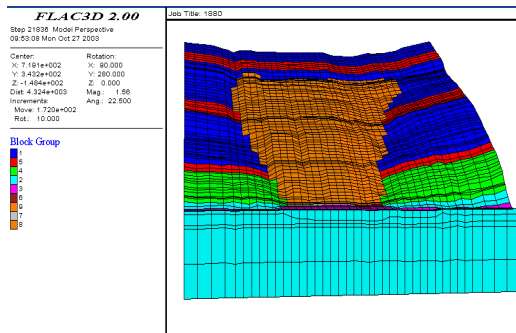
Figure 1. 3D numerical model

It mainly consisted of main slide, secondary slide, slope body and alleviation (Figure 1). The slope body consisted of two parts, the upstream one and the downstream one. The parameter data of the upstream one are higher than the downstream one.

The slope body is modelled as elastic-plastic and the bedrock as elastic in the model. The calculation only considered the affect of gravity, and mainly considered its stability under the condition of the normal impounded level, whose elevation is 1880m.

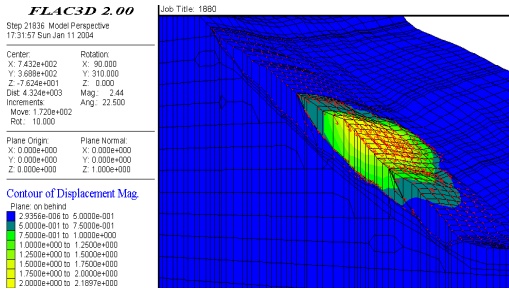
The displacement magnitude moved downward along the dip direction of the slope after the normal impounded level (Figure 2). The part above 1920 m elevation mainly moved downward, the other mainly moved in a horizontal direction, especially the superficial part.

Figure 2. Contour map of U-Displacement

The displacement magnitude is larger in the middle part than in the upper and lower parts; and it is larger in the superficial part than in the interior part, so large displacements local to the middle and superficial part may indicate failure. The displacement magnitude is more than 0.5 m between 1850 and 1900 m; 0.5 to 0.7 m between 1720 and 1780 m and between 1920 and 1960 m. It is 0.7 to 1.75 m between 1780 and 1850 m and between 1900 and 1920 m. It is 1.75 to 2.17 m between 1850 and 1900 m. Elsewhere, it is less than 0.5 m, and there are no displacement in some parts. In the vertical direction, the dispersion of displacement is 0.25 m every 10 to 15 m in depth; the displacement is 1.75 to 2.17 m within 10 m depth in the superficial part; it is less than the others in the slope. Its displacement is 0.75 to 1.00 m close to the slope bottom.

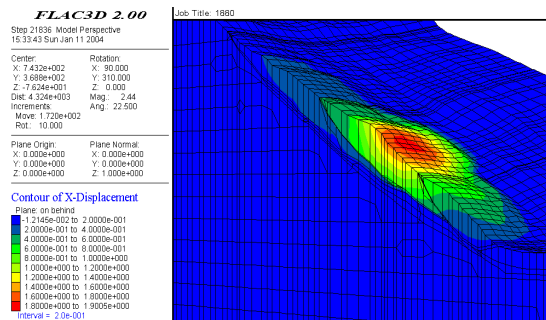
Figure 3 shows that the slope has two areas: the upper one is sliding-gently and sinking and the middle and lower one is sliding.

Figure 3. Contour map of horizontal displacement

Sliding-sinking areas: sliding area lies in the upper part between 2080 and 2120 m; its length is about 50 m from 2080 to 2120 m in the direction and its sinking displacement is about 1.2 m in the vertical direction. When the part slides to the lower part, there were a series of cracks in the back during its deformation so that the rock and soil sink along them. The depth is 1.2m.

Sliding areas: this is the part from 2080 m to the front part of the area. Its sliding direction is mainly toward the front part; its displacement is from 0 to 1.9 m. Its displacement is more than 0.40 m from 1960 m to the front part. The highest displacement is more than 1.00 m between 1920 and 1800 m.

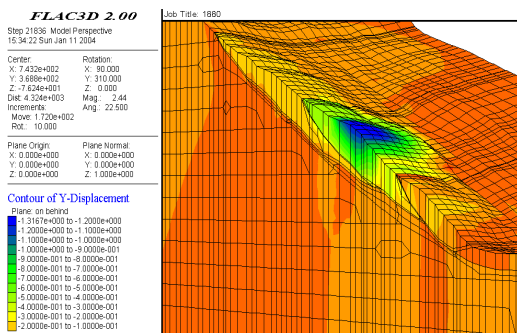
Figure 4 shows that the slope is wholly sinking, that is, its displacement direction is downward. The settlement value is direct proportional to the thickness of the slope body; further, the settlement of superficial part is larger than the settlement of the middle and deep parts. The settlement is largest between the secondary sliding surface and the tertiary sliding surface, in particular, it is more than 1 m within the 40~50 m depth between 1920 and 1800 m.

Figure 4. Contour map of vertical displacement

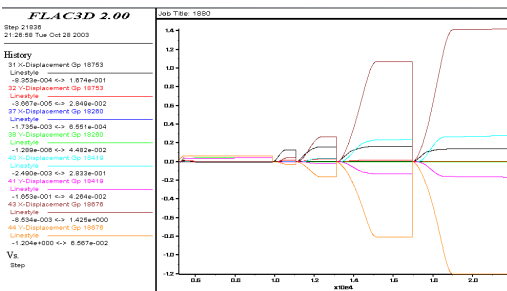
Some monitoring points were placed on the upper part, middle part and lower part of the slope. The points kept trace of the horizontal and vertical displacements, as shown on Figure 5. Horizontal displacement will gradually increase with the rising level of impoundment. When the impounded level is 1850 m, the horizontal displacement will be more than 1.2 m and the slope will partially fail. The deformation and damage are predicted to become greater and wider, possibly leading to partial failure, when the impounded water level reaches 1880 m. Furthermore, Figure 5 also shows that the displacement is larger in the middle part (18419 point and 19676 point) than in the upper (18260 point) and lower (18753 point) parts.

Figure 5. Displacement Histories at Some Points in the Slope

Y-displacement is predicted to move upward during the initial stages, but will move downward after the initial stages. The settlement will gradually increase with the rising level of impoundment. When the impounded level reaches 1850 m, the Y-displacement is predicted to be more than 0.8 m and the model shows the slope partially to fail. The deformation and damage are predicted to become greater and wider, possibly leading to partial failure, when the impounded water level reaches 1880m. The Y-displacement is more than 1.2 m when the impounded water level reaches 1880m. Furthermore, the figure also shows that the displacement is larger in the middle than in the upper and lower parts.
